Environmental Impact Assessment:
The Central Bank of The Bahamas
New Premises - REVISION 1

06 September 2021

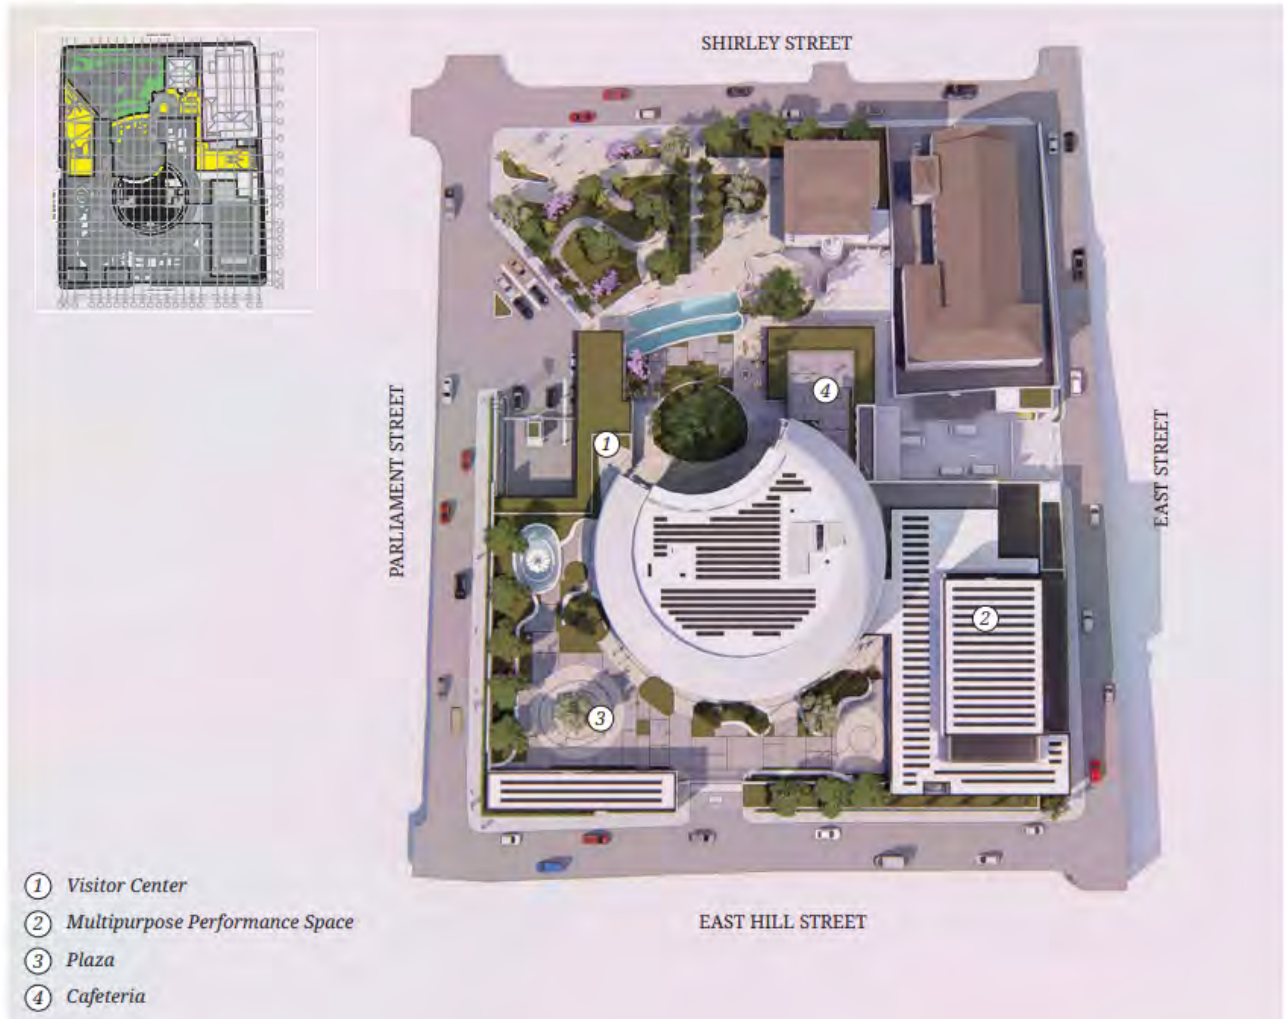
Offices, Campus Amenity Spaces, Ancillary Spaces & Parking for 214 vehicles, all over 8 levels (2 levels below grade, 5 levels above grade, plus roof level):

LEVEL B2	LEVEL 3
FIT OUT: 13,428 SF	INTERIOR: 16,734 SF
PARKING: 49,031 SF	EXTERIOR: 663 SF
ALL: 62,459 SF	ALL: 17,397 SF
LEVEL B1	LEVEL 4
FIT OUT: 33,553 SF	INTERIOR: 14,736 SF
PARKING: 38,625 SF	EXTERIOR: 3,352 SF
YARD: 7,349 SF	ALL: 18,397 SF
LEVEL 1	LEVEL 5
FIT OUT: 24,571 SF	INTERIOR: 12,350 SF
PLAZA/ROOF: 47,140 SF	EXTERIOR: 3,331 SF
ALL: 71,711 SF	ALL: 15,681 SF
LEVEL 2	ROOF LEVEL
INTERIOR: 17,496 SF	INTERIOR: 532 SF
EXTERIOR: 360 SF	EXTERIOR: 10,931 SF
ALL: 17,856 SF	ALL: 11,463 SF

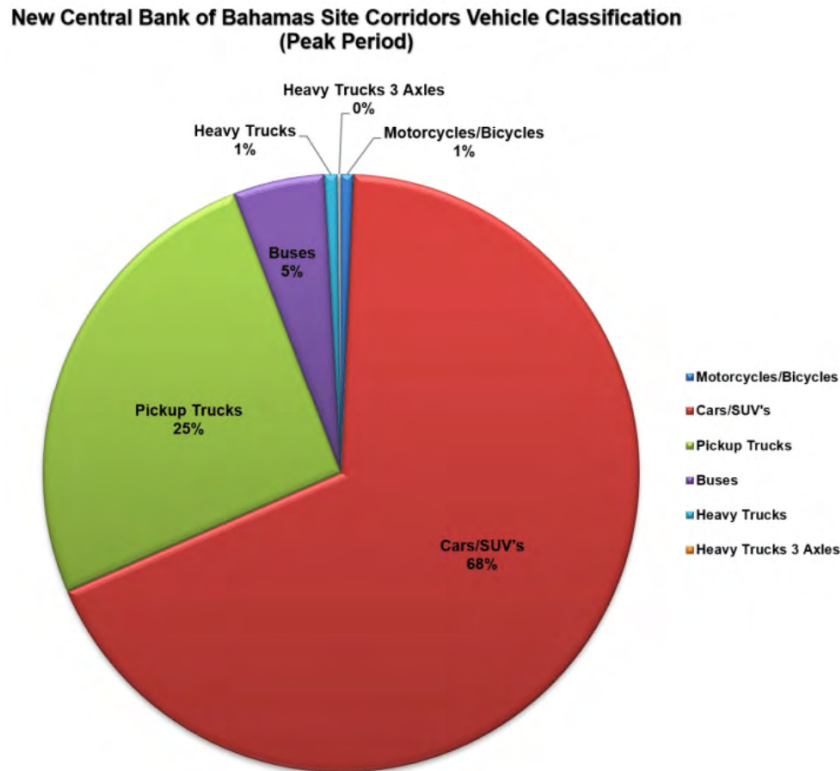
Figure 19. Vehicle classification adjacent to CBOB site

Four (4) major thoroughfares surround the proposed development site, inclusive of Shirley Street, East Street, East Hill Street and Parliament Street. The busiest of these streets in terms of public transportation would include Shirley Street (20 bus routes), East Hill Street (25 bus routes) and East Street (23 bus routes). Parliament Street is also included in the bus routes; however its routes are minimal in total compared to the three others (8 bus routes). Various bus routes (identifiable by route number) frequent all four streets in passing and to arrive at the bus depot Downtown. Shirley Street acts as a service street for Bay and Parliament Streets. East Street runs from north to south on the island of New Providence. Its location near the proposed site is known as East Street (north) and is a major road to connect to Bay and Shirley Street. East Hill Street connects traffic to the one way Market Street to escape the immediate downtown area. Besides the major public transportation system, these roads are used by motor vehicles quite often. The pie chart in Figure 20 illustrates the classification of vehicles that frequent the streets near the proposed development.

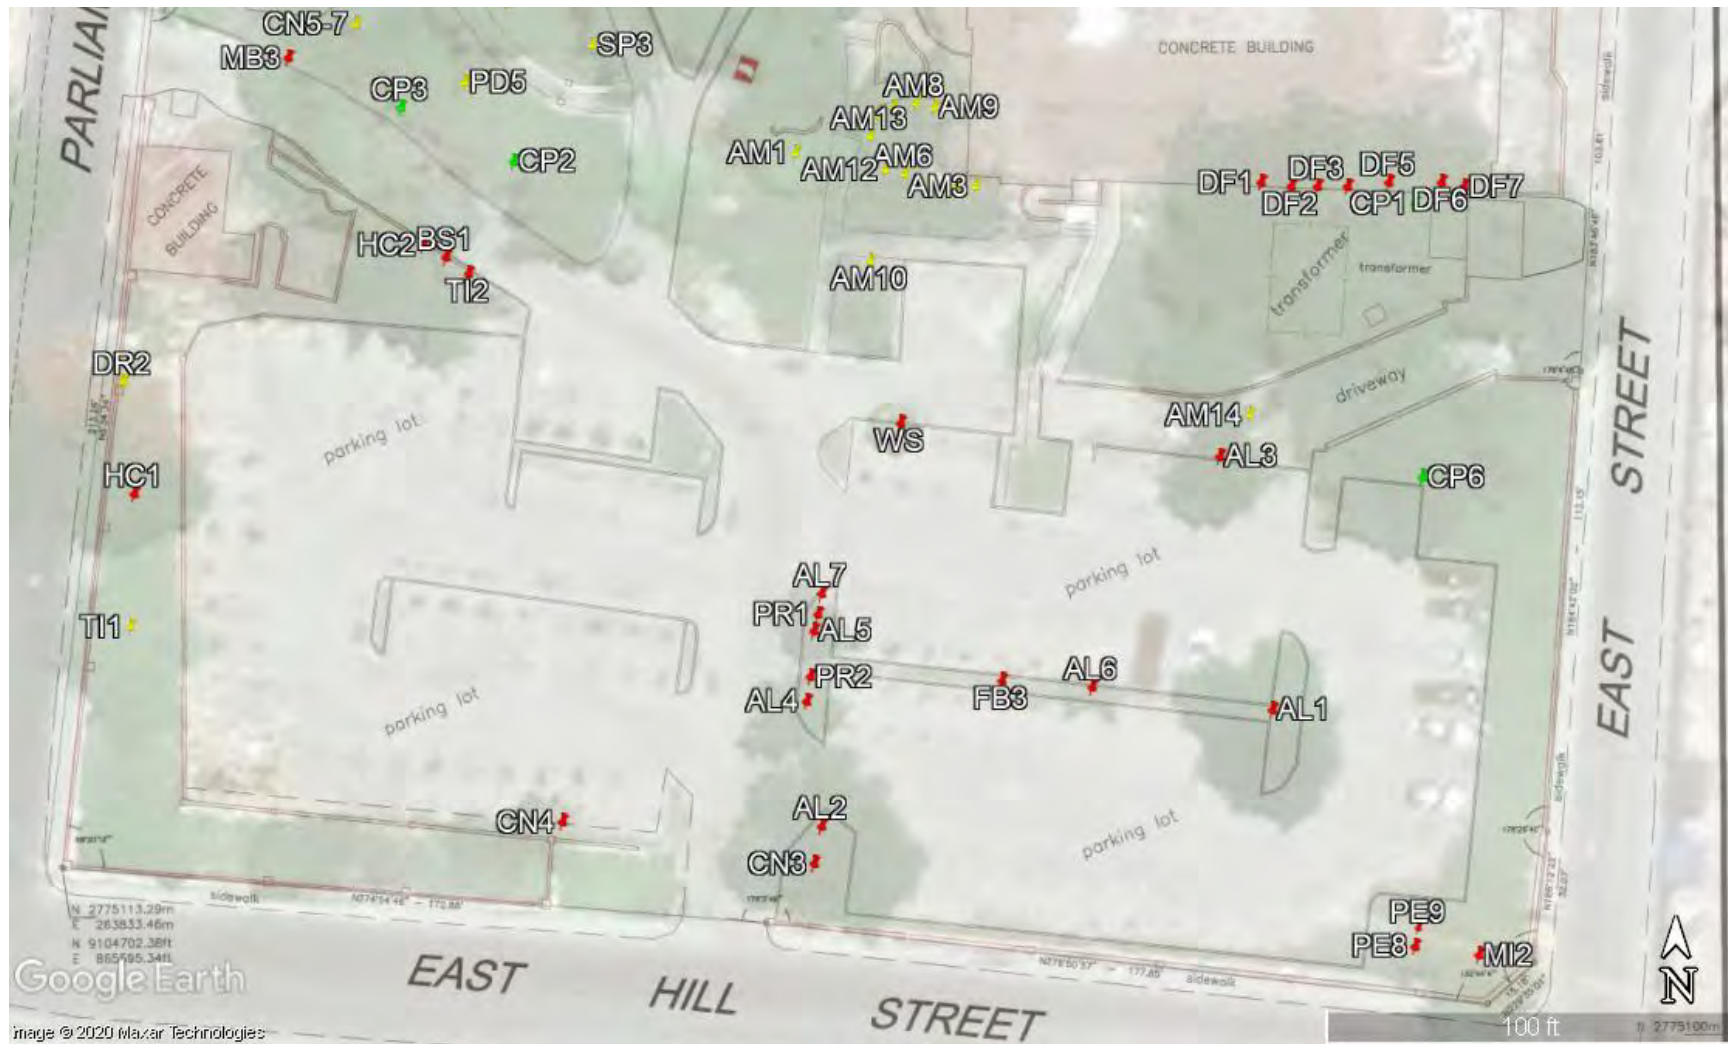
Figure 66. Site map with tree preservation/removal codes (Southern portion of property)

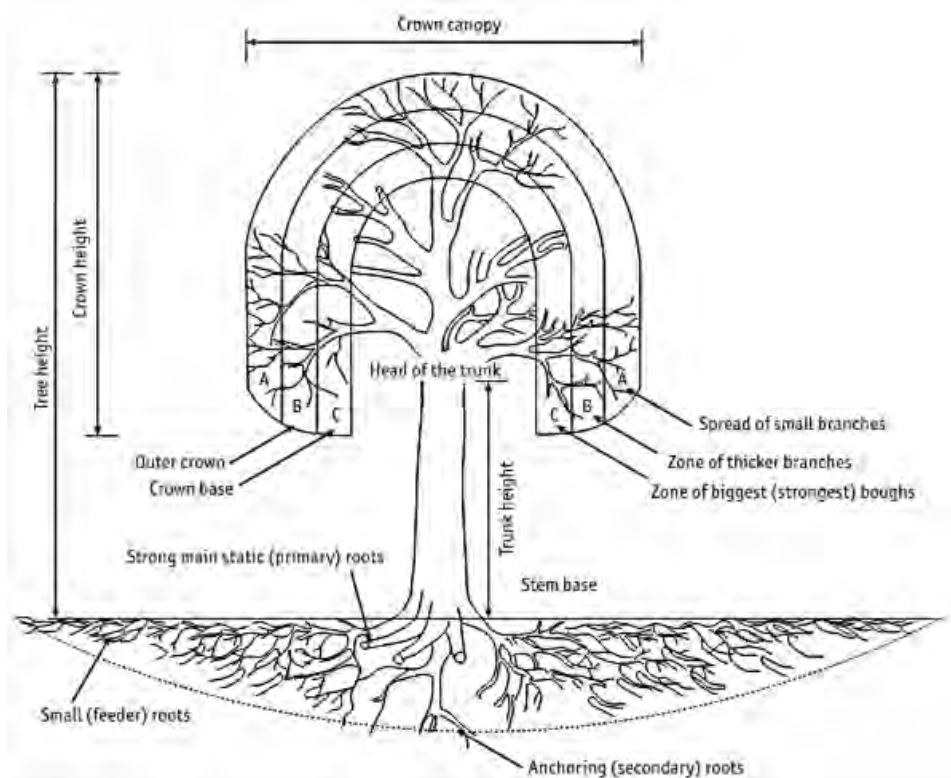
Figure 69. Diagram of tree elements

Soil compaction due to vehicular or foot traffic compresses the soil particles, interfering with gaseous exchange in the sensitive root zone within the upper 24 inches of topsoil. Soil compaction also interferes with soil permeability, altering water flow to tree roots. Severe cases of soil compaction be lethal to specimen trees if not mitigated against or remedied.

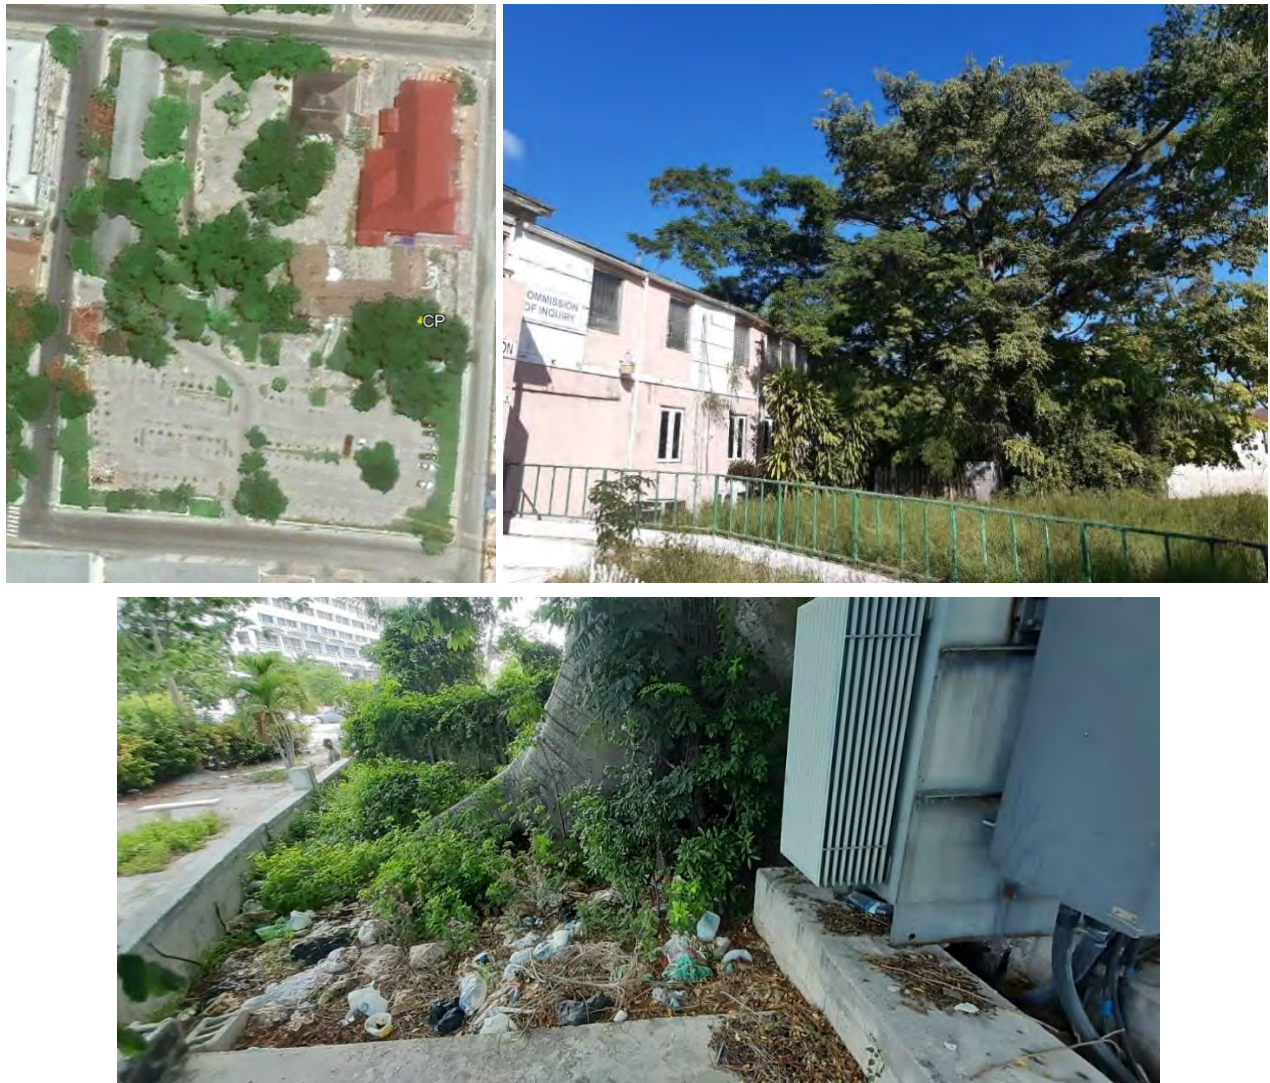
CP1 is most at risk from the demolition of the COI Building and other existing infrastructure within its CRZ, including the retaining wall and BPL infrastructure along the existing eastern entrance driveway. Tree protection for this species would include avoiding the use of heavy equipment and machinery within the CRZ, retaining the existing grade within the CRZ, use of hand power tools for demo of concrete structure within the CRZ and general care/awareness to avoid physical damage to the individuals via direct contact with machinery or falling debris during demo. The walls and COI infrastructure are considered to have restricted the trees roots from extending completely within the CRZ or having its surface roots extend beneath the concrete foundations. Most of the surface roots, critical for air exchange and tree stability, are located west of the tree in the lawned spaces south of the

COI building. Preservation of the upper 10-12 inches of soil is critical for the survival of these surface roots. Removal of existing vegetation or pavement/concrete within the CRZ should be immediately followed by an application of a mulch layer 4-6 inches deep, and supplemental irrigation to decrease the chances of water stress on this individual.

Figure 80. Location of CP1 on project site (left), CP1 position relative to COI Building (right) & CP1 position relative to BPL infrastructure (bottom).

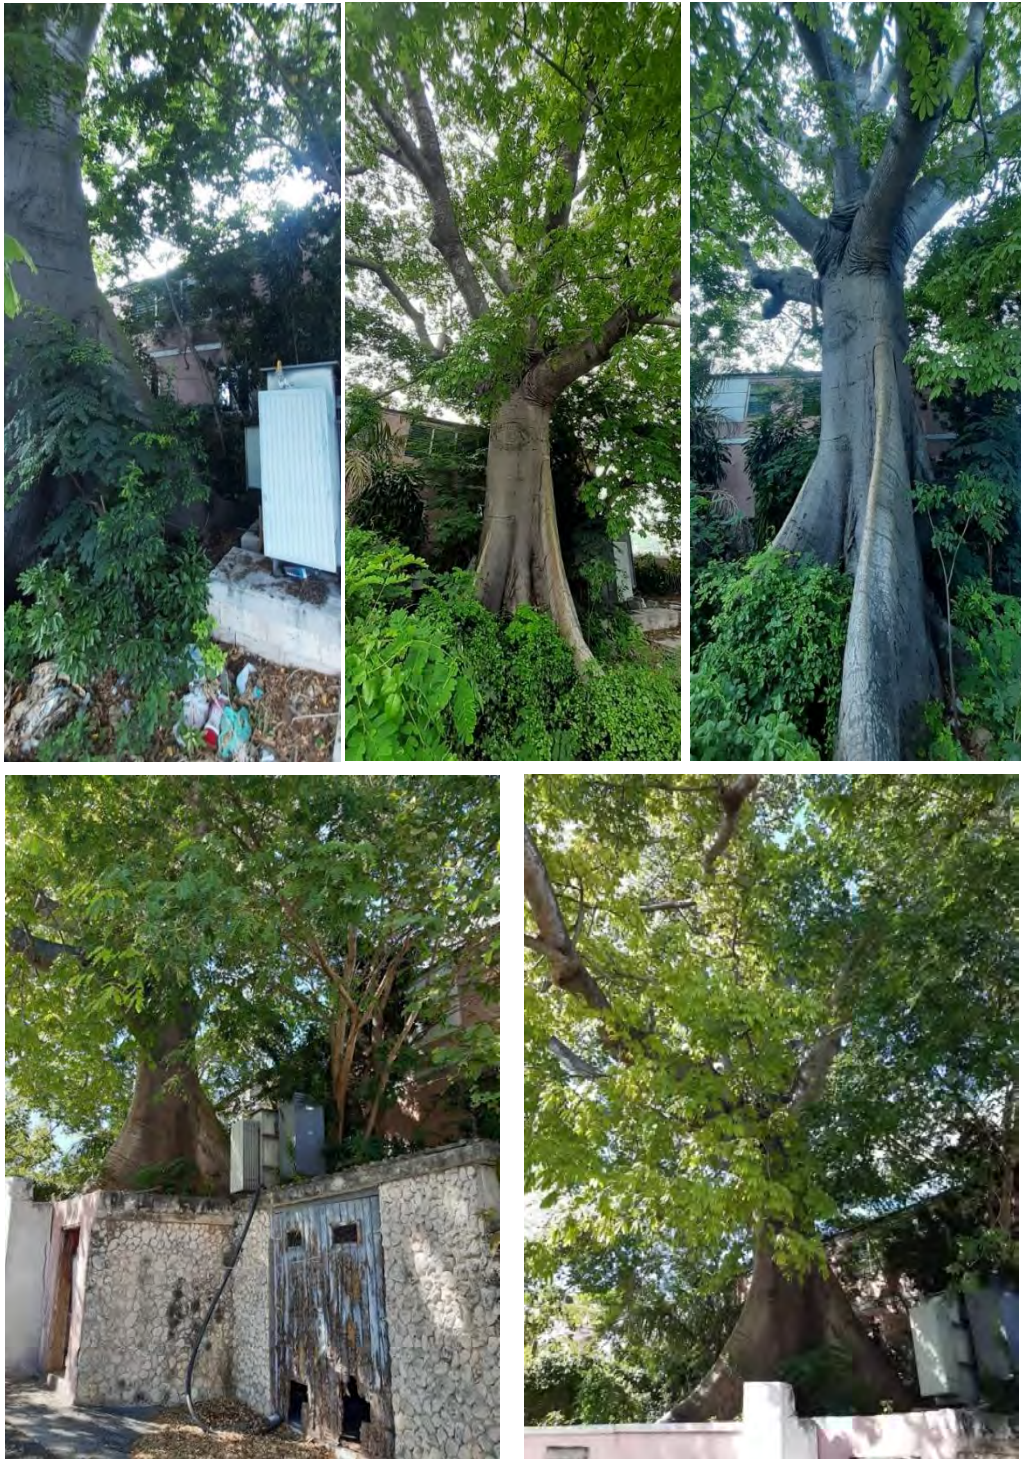
Figure 81. Position of CP1 relative to BPL infrastructure

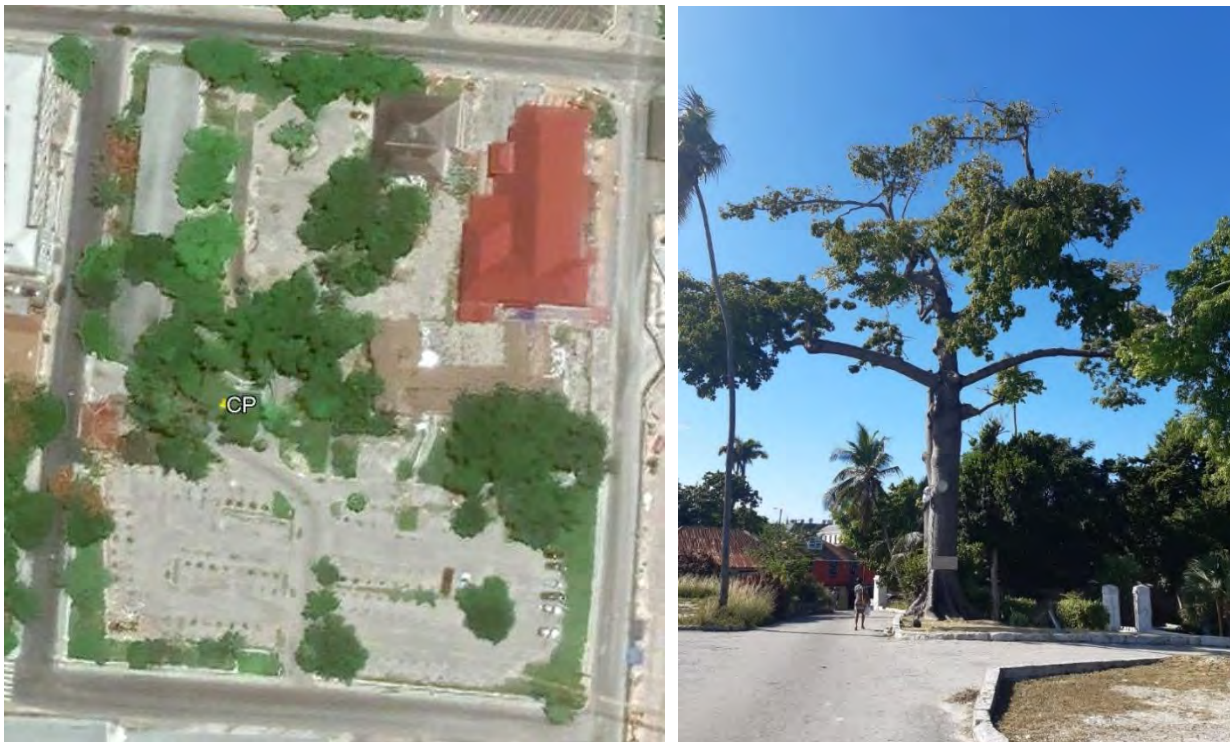
The two specimens CP2 and CP3 are located along the western entrance of the property and are adjacent to one another and the proposed footprint of the new building. CP3 is showing sign of rot at its apex, where its main trunk has been broken/severed, and could be retained in the landscape if desired. However this particular specimen appears to be the least healthy of all, and could be a candidate for removal. If CP2 can be integrated into the landscape design, due to its proximity to CP3, it would need to be carefully preserved during removal of CP3, with special care not to disturb the surface roots within the CRZ. Demolition of the existing entrance road and nearby pathway should occur by hand powered tools. Excavation and construction activities on the new building can potentially impact CP2 through collisions with heavy equipment, change of site grading, compression of roots and soil within its CRZ, among other threats. Its proximity to the proposed building footprint puts it at high risk for negative impacts, and its preservation may require adjustment to the design/layout of the current site plan. If site changes are not feasible, this specimen may be removed in conjunction with CP3.

Figure 82. Location of CP2 on project site

CP2	One of two specimens near to the western entrance.	DBH of main trunk 2m Canopy spread: North 51ft East 58ft South 50ft West 28.5 ft CRZ 30ft radius	Overall a healthy specimen which has had previous pruning exercises or broken branches. No readily apparent sign of disease on main trunk or branches. Signs of predation from sap sucking birds and insects. Leaves showing tip burn and some stress.	Specimen potentially within direct area of impact of new building. Located alongside the entrance driveway, the specimen risk physical damage through collision and root compaction by heavy vehicles operating onsite.	Remove if design changes and protection measures are not feasible.
CP 3	Second specimen located near to western	Main trunk DBH 1.7m Canopy spread: 30ft	Overall health of the specimen is stressed. The primary axis has been damaged	Specimen potentially within direct area of impact of new building and associated infrastructure. Located	Remove specimen if protection measures and site design modification unfeasible.

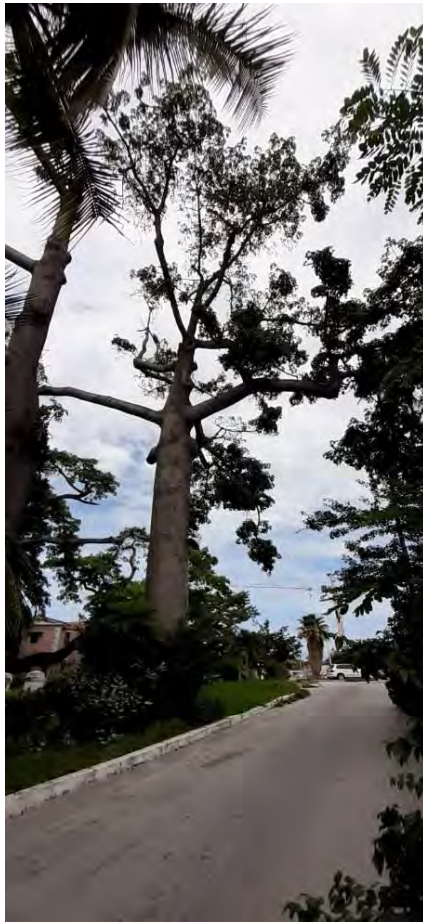
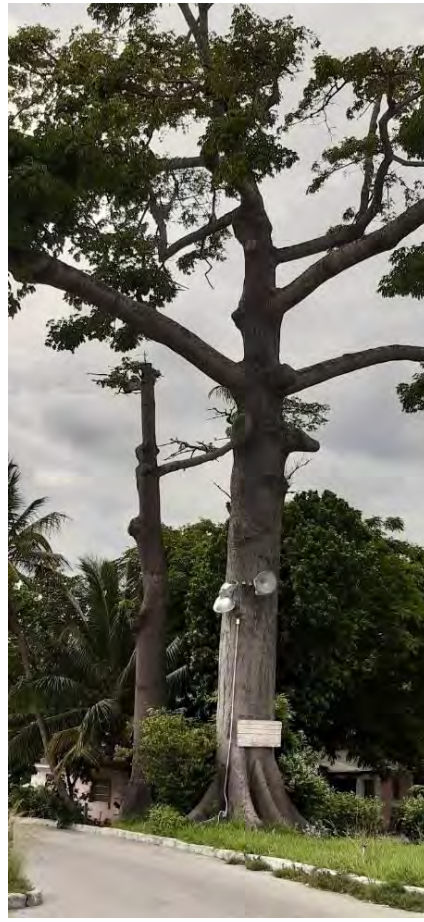
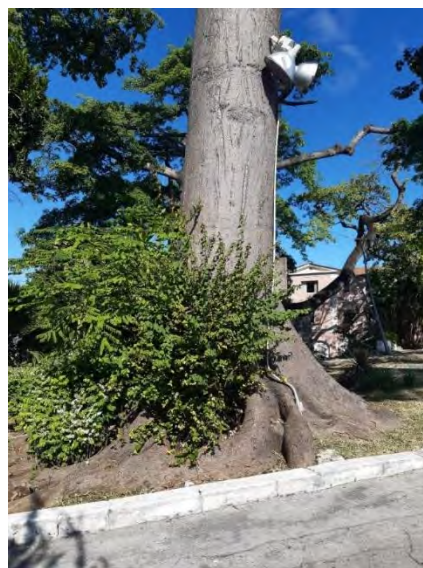
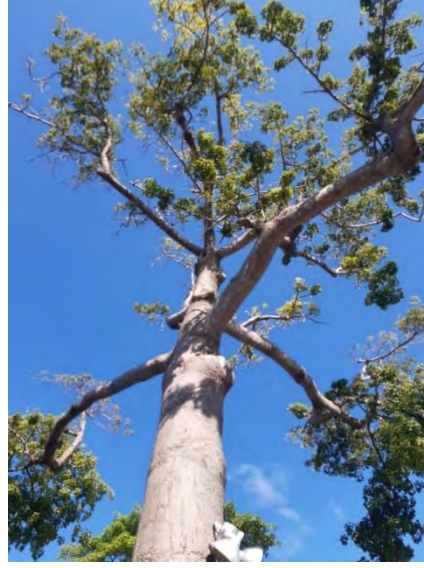
Figure 83. Position of CP2 relative to western entrance of site

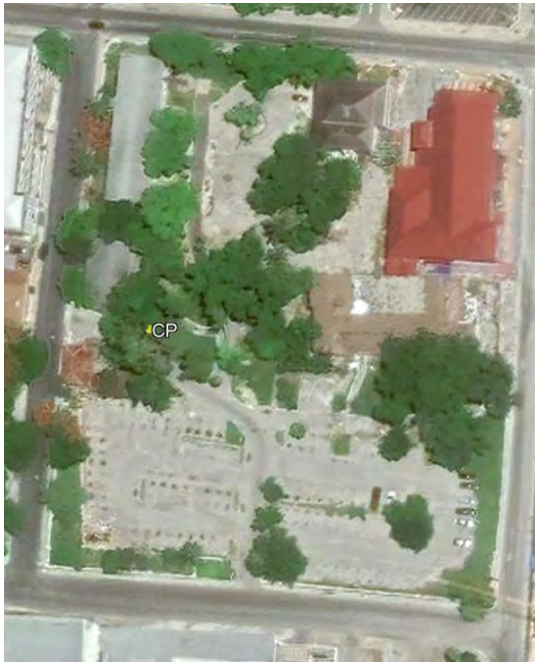
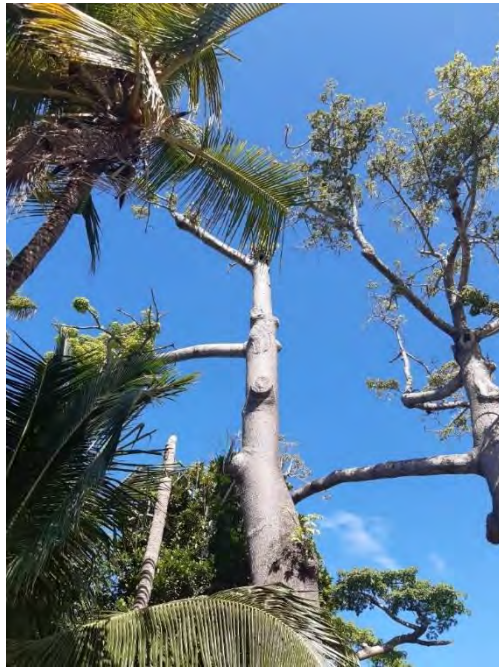
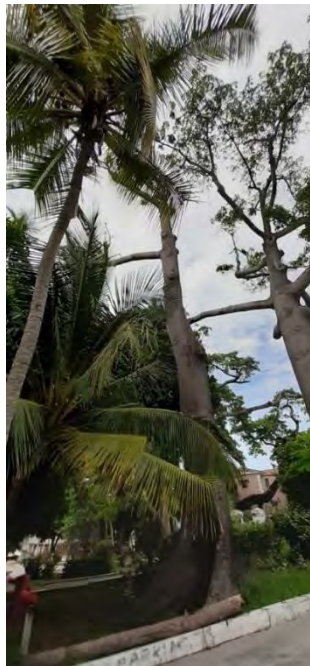
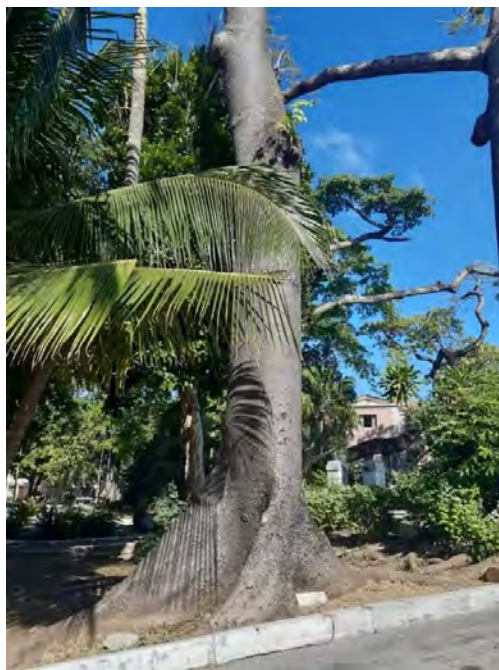
Figure 84. CP3 location on the project site, and position relative to the western entrance driveway.

entrance of property.	CRZ 30ft radius	and/or cut and lateral branches broken or severed. Visible signs of rot at the top of main trunk where primary axis was severed.	alongside the entrance driveway, the specimen risks physical damage through collision and root compaction by heavy vehicles operating onsite. Already stressed and damaged, any negative impacts from construction activities will promote continued deterioration of the specimen.	
CP4	Iconic tree to the former Hotel and Garden site. Formerly utilized as a bar and leisure spot by hotel and garden's guests. Photographic evidence confirms age of specimen to be 200+ years old.	Canopy Spread: South 66ft SE 76ft East 60ft North 52ft NW 34ft West 32 ft DBH ~4m CRZ 45ft radius Large central mother tree with 4 main branches beginning at 2m above the ground. Two of the main branches grow vertically and two horizontally. The horizontal branch on the eastern side of specimen is currently supported by a steel cable from distal end of branch to main trunk and by concrete support at the proximal end of the branch. Majority of tree weight is distributed on the southern and south-eastern sides of specimen. Surface roots visible	Steel cable has collared branch and has been subsumed into branch tissue. Beyond collared area of branch there are no obvious signs of stress. Lateral roots have grown through the concrete support into the ground, providing additional support for the branch's weight. Tree has nails, wood, metal pieces, wires inserted at various parts of main trunk and branches. Has suffered branch damage in past due to rough weather.	Physical damage of above and below ground plant parts by heavy equipment or trenching activities near to the exclusion zone. Alteration of ground chemistry due to construction activities. Age and resistance to sever weather/hurricanes. Susceptible to pests and disease under stressed conditions. Damage to eastern branch during demolition of COI building. Collapse of concrete support or steel cable support. Deposition of dust on leaves of specimen may reduce photosynthesis in specimen. Toxic or caustic dust particles can induce physical and chemical damage to specimen.	Prior to any demolition works in these areas, all surface roots are to be properly flagged and marked. Additional interventions to preserve main lateral branch by bolstering support beneath and replacing steel cable support with less damaging means. Establishment of protective buffer around the root exclusion zoon, to coincide with the drip line of the specimen. Subterranean barrier to prevent ground contamination from nearby construction activities. Supplemental drip irrigation and fertigation to be installed and supplied prior to trenching activities outside of root exclusion zone. Regular soil testing to ensure pH, soil moisture and nutrient content do not adversely impact the

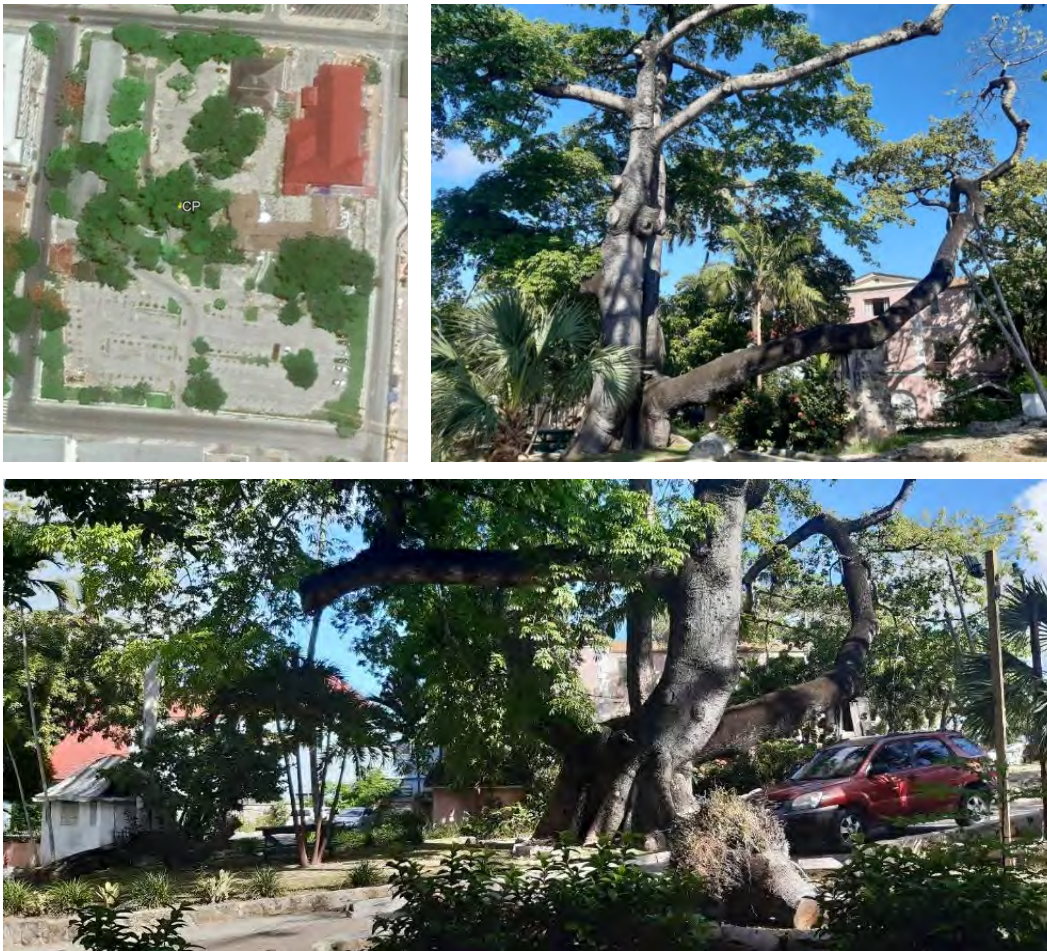
Figure 85. Location of CP4 on the project site, and position relative to central driveway

The featured specimen on the site CP4 is highly valued due to its large stature, unique architecture and historical significance to the Royal Victoria Gardens. Preserving this individual in place should be a desired goal of the Project Owner, as this specimen embodies the character of the Garden's illustrious past. The protection of this specimen will require strict enforcement of the CRZ, especially in areas where surface roots are visible (in soil/lawn areas and display beds surrounding the specimen). The unique south-eastern facing horizontal branch extends within close proximity to the COI building, and extreme caution should be taken to avoid damage to this branch during demolition activities. Excavation and construction activities on the new building can potentially impact CP2 through collisions with heavy equipment, change of site grading, compression of roots and soil within its CRZ, among other threats. Its close proximity to the proposed building footprint puts it at high risk for negative impacts, and its preservation may require adjustment to the design/layout of the current site plan. A paved driveway passes alongside the specimen on its western side, and along with the planter's low retaining walls, have effectively covered and cut off surface roots to the west of the tree. Despite no visible surface roots on this side of the tree, no excavation or trenching activity is proposed for the areas within its CRZ. Removal of pavement/concrete surfaces within the CRZ should be done with hand powered tools, with care taken not to damage the underlying roots.

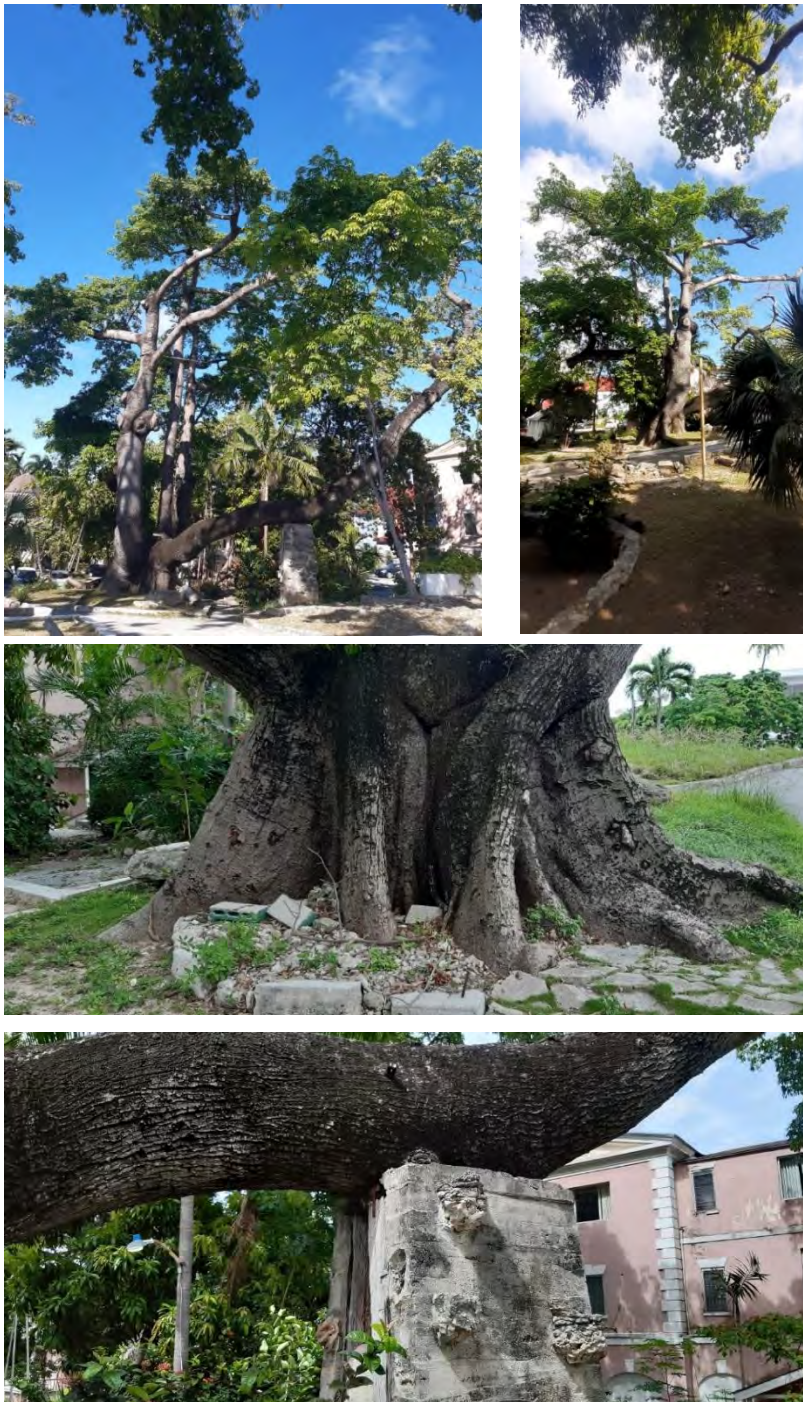
Figure 86. Images of CP4 illustrating overall structure (top), main trunk (center) and concrete support under large horizontal branch

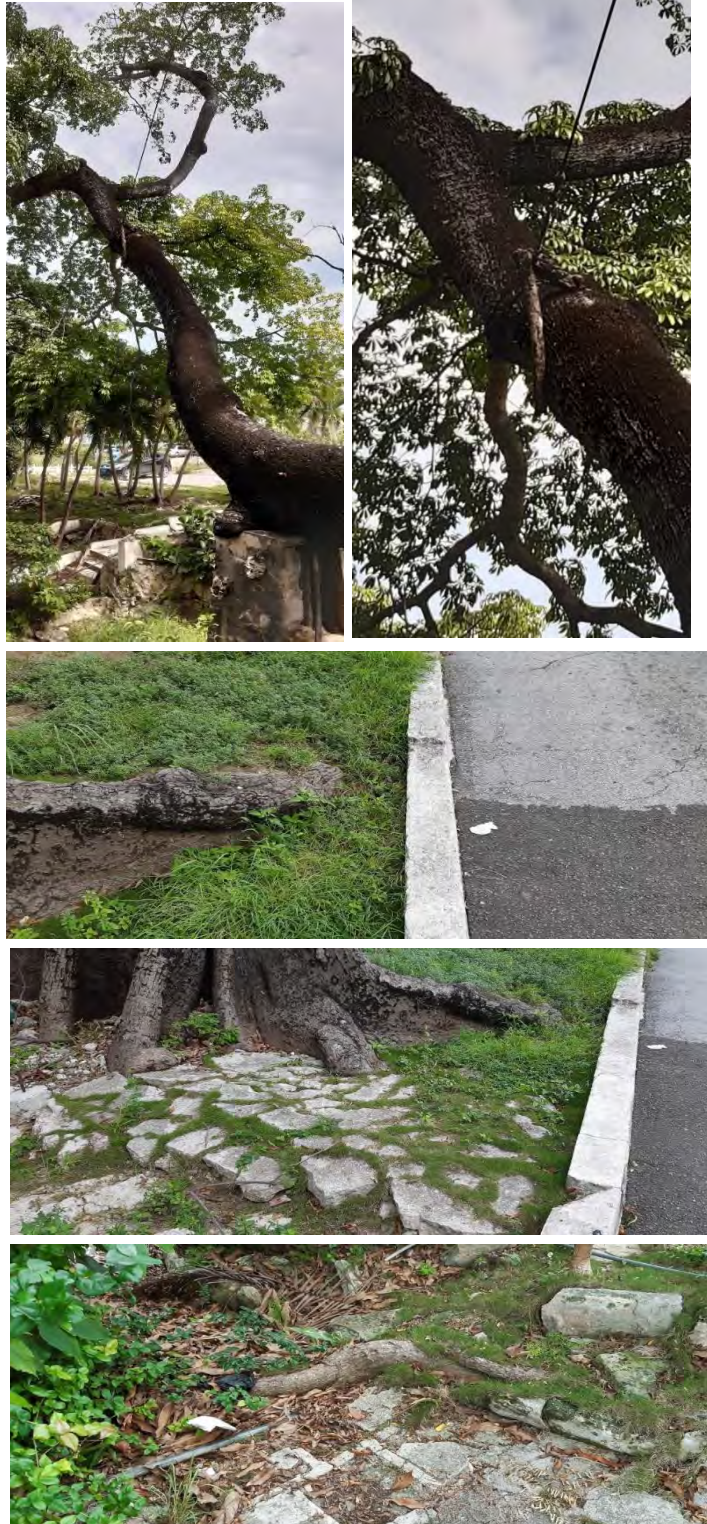
Figure 87. Images of CP4 showing steel cable support on horizontal branch (top) and visible surface roots near to trunk of tree (center, bottom).

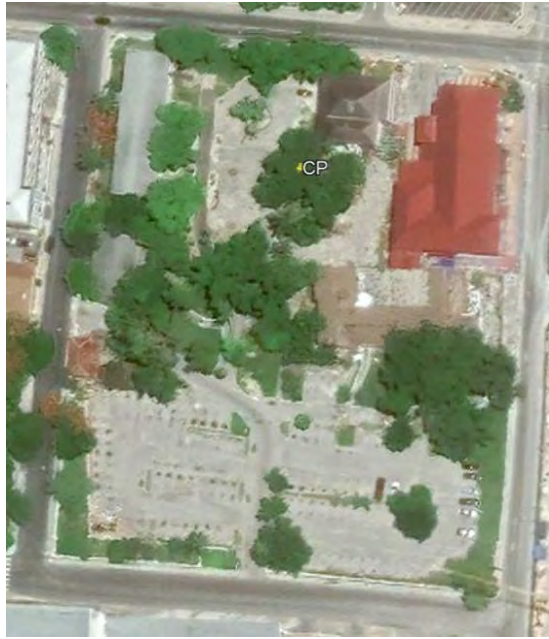
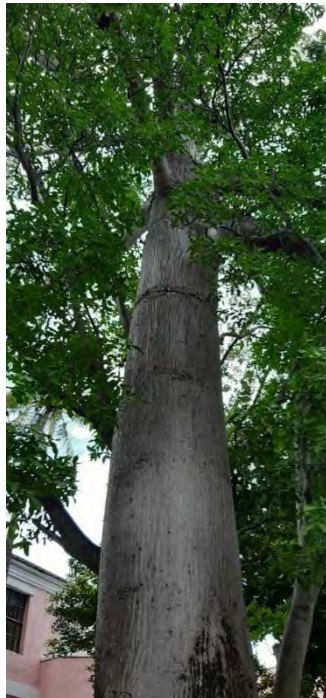
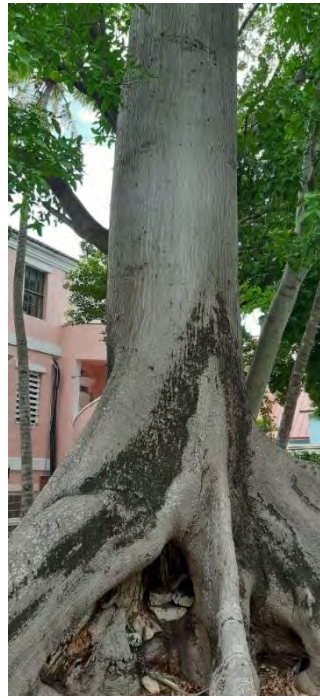
Figure 88. Position of CP5 on project site (top) and images showing main trunk and buttress roots (bottom).

CP5 is located in the northern area of the property, just south of the National Reference Laboratory. Nearby infrastructure also include the AC and generator units for the Reference Laboratory, as well as the old pool area for the former Royal Victoria Hotel. Despite this specimen exhibiting signs of rot and damage at its base, the tree remains healthy with a broad canopy, showing no signs of stress. The opportunity exists to preserve this tree in place with minimal risk to the CRZ once no major construction and demolition activities occur near to the specimen.

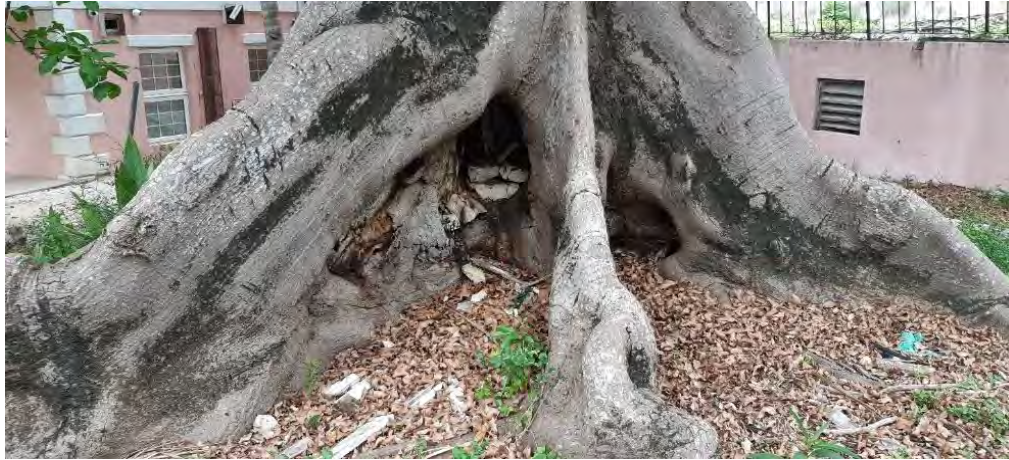
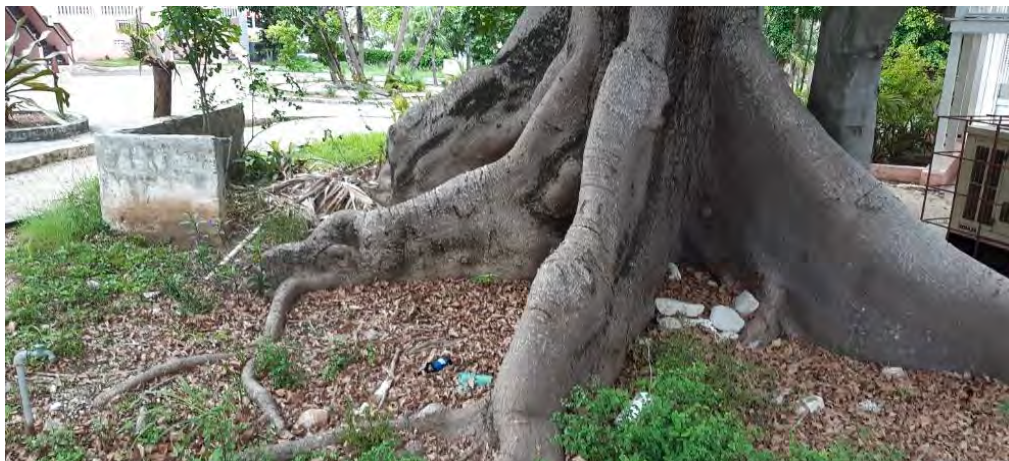
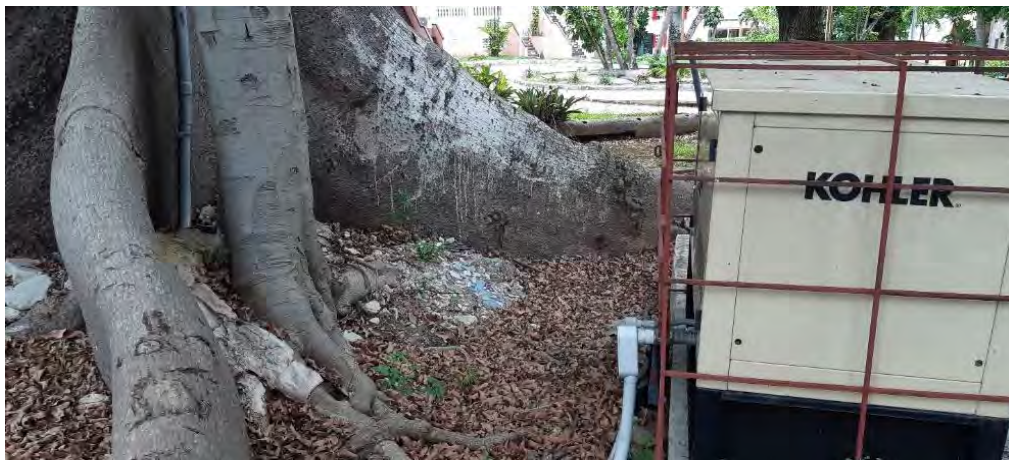
Figure 89. Images of CP5 illustrating root structure and showing proximity to Reference Laboratory generator and AC unit

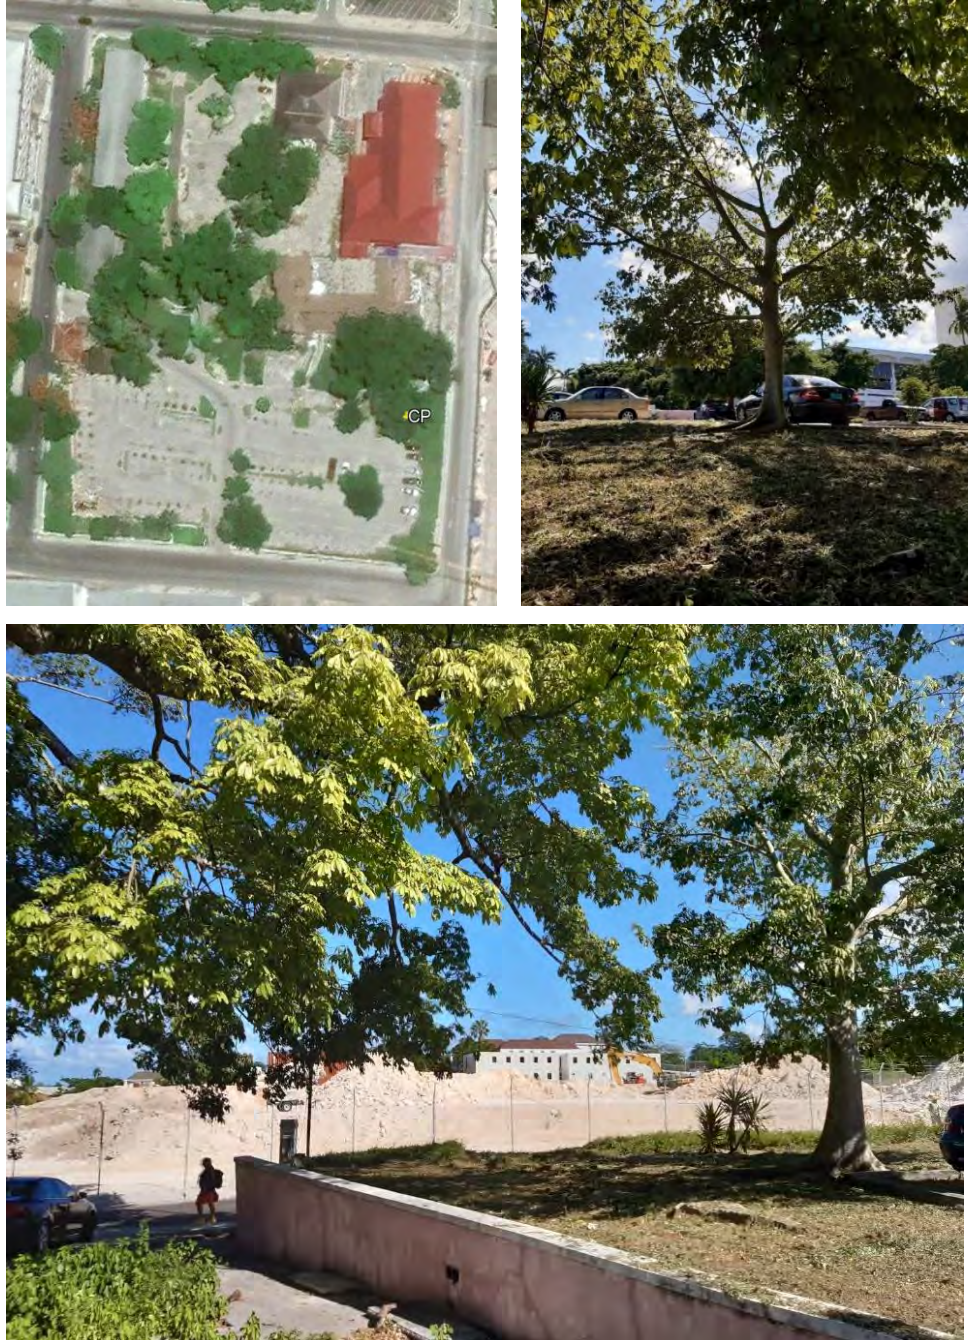
Figure 90. Location of CP6 on project site and location relative to parking lot and east entrance driveway

CP6 is a juvenile specimen located south of CP1 in the lawn area bordering the parking lot. This tree is a healthy juvenile, with no signs of stress or disease. Threats to this specimen are related to the construction activities, as it is located within the proposed footprint of the new building. Land clearing and excavation activities in preparation for construction would require removal of this specimen if adjusting the site design and/or layout is not feasible.

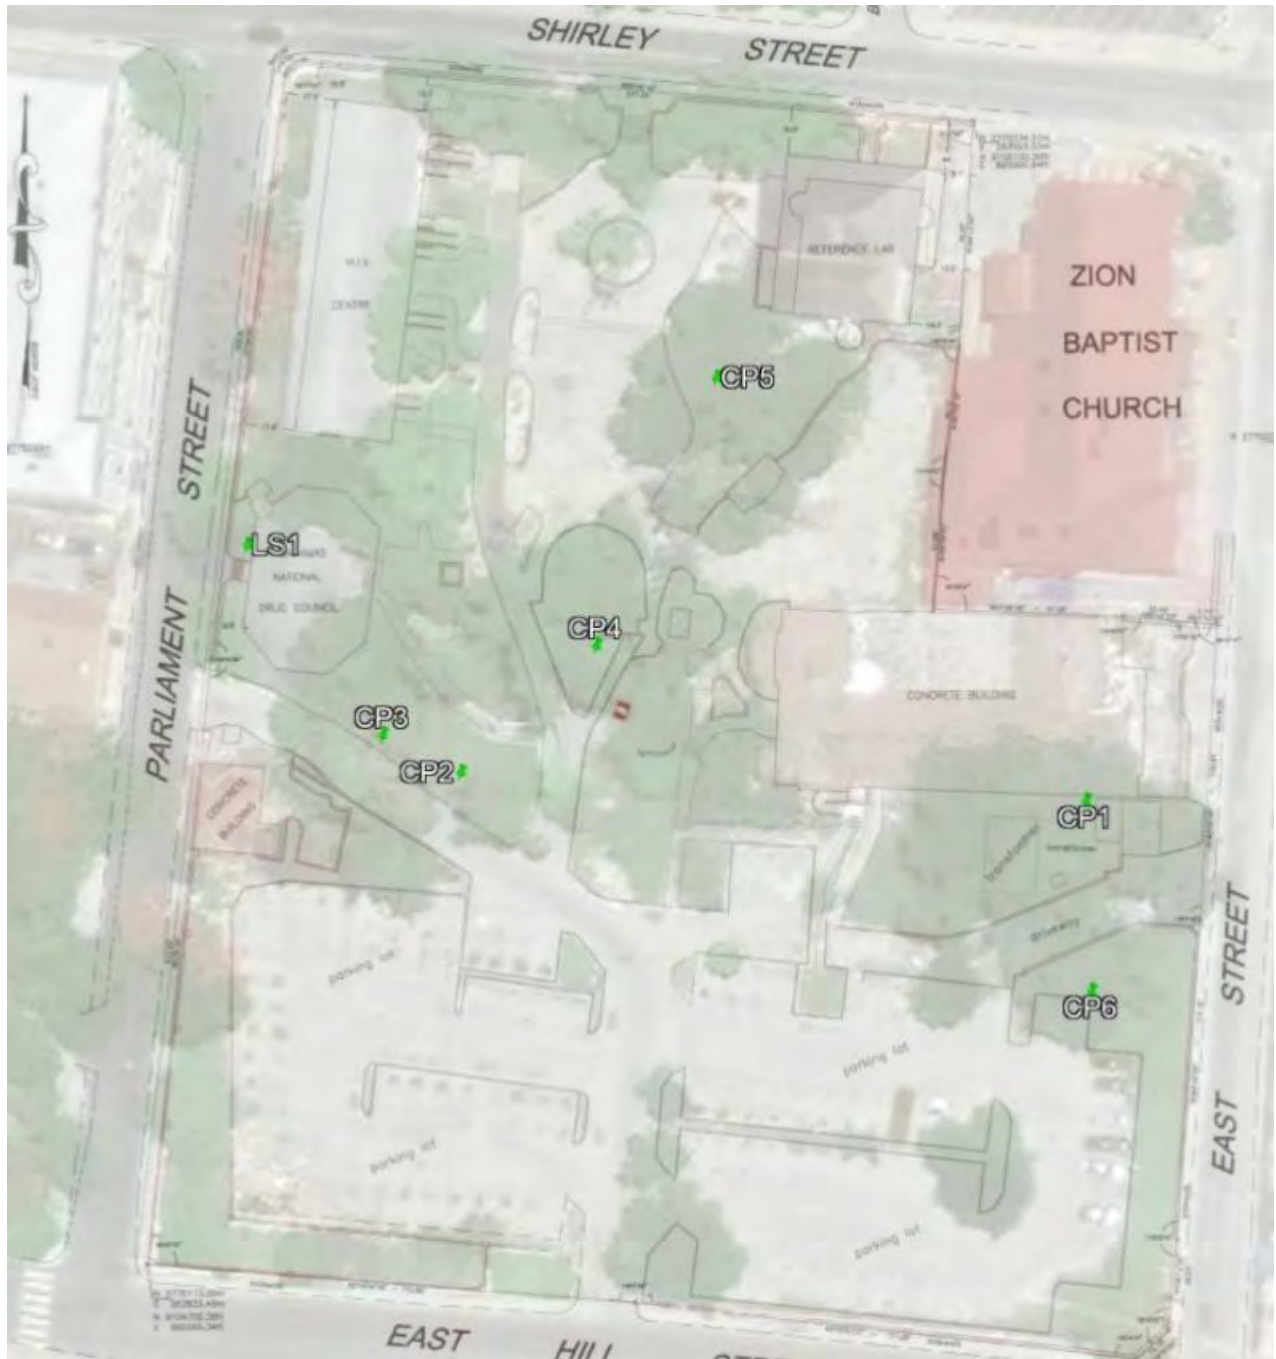
Figure 93. Site map depicting location of nationally protected species of trees on the Project Site
