Environmental Impact Assessment:
The Central Bank of The Bahamas
New Premises - REVISION 1

06 September 2021

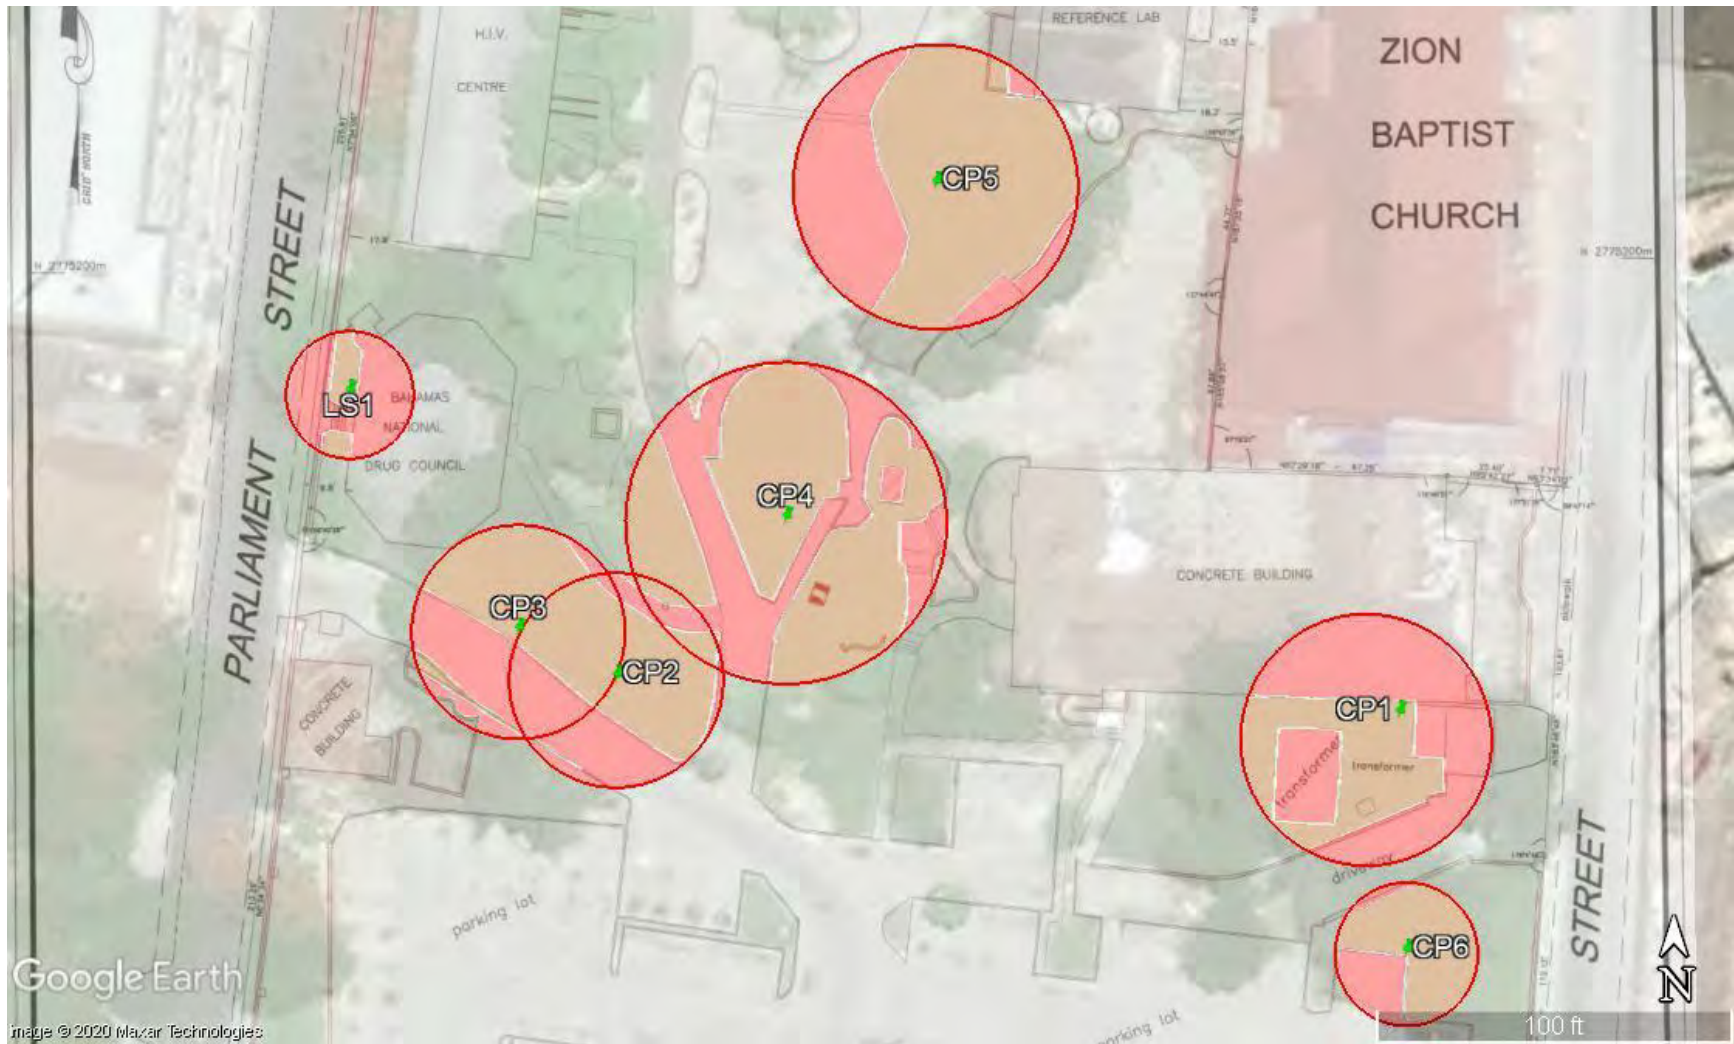
Figure 95. Site map with protected tree species, their respective CRZ, and color code for surface type (soil/lawn vs pavement/concrete)

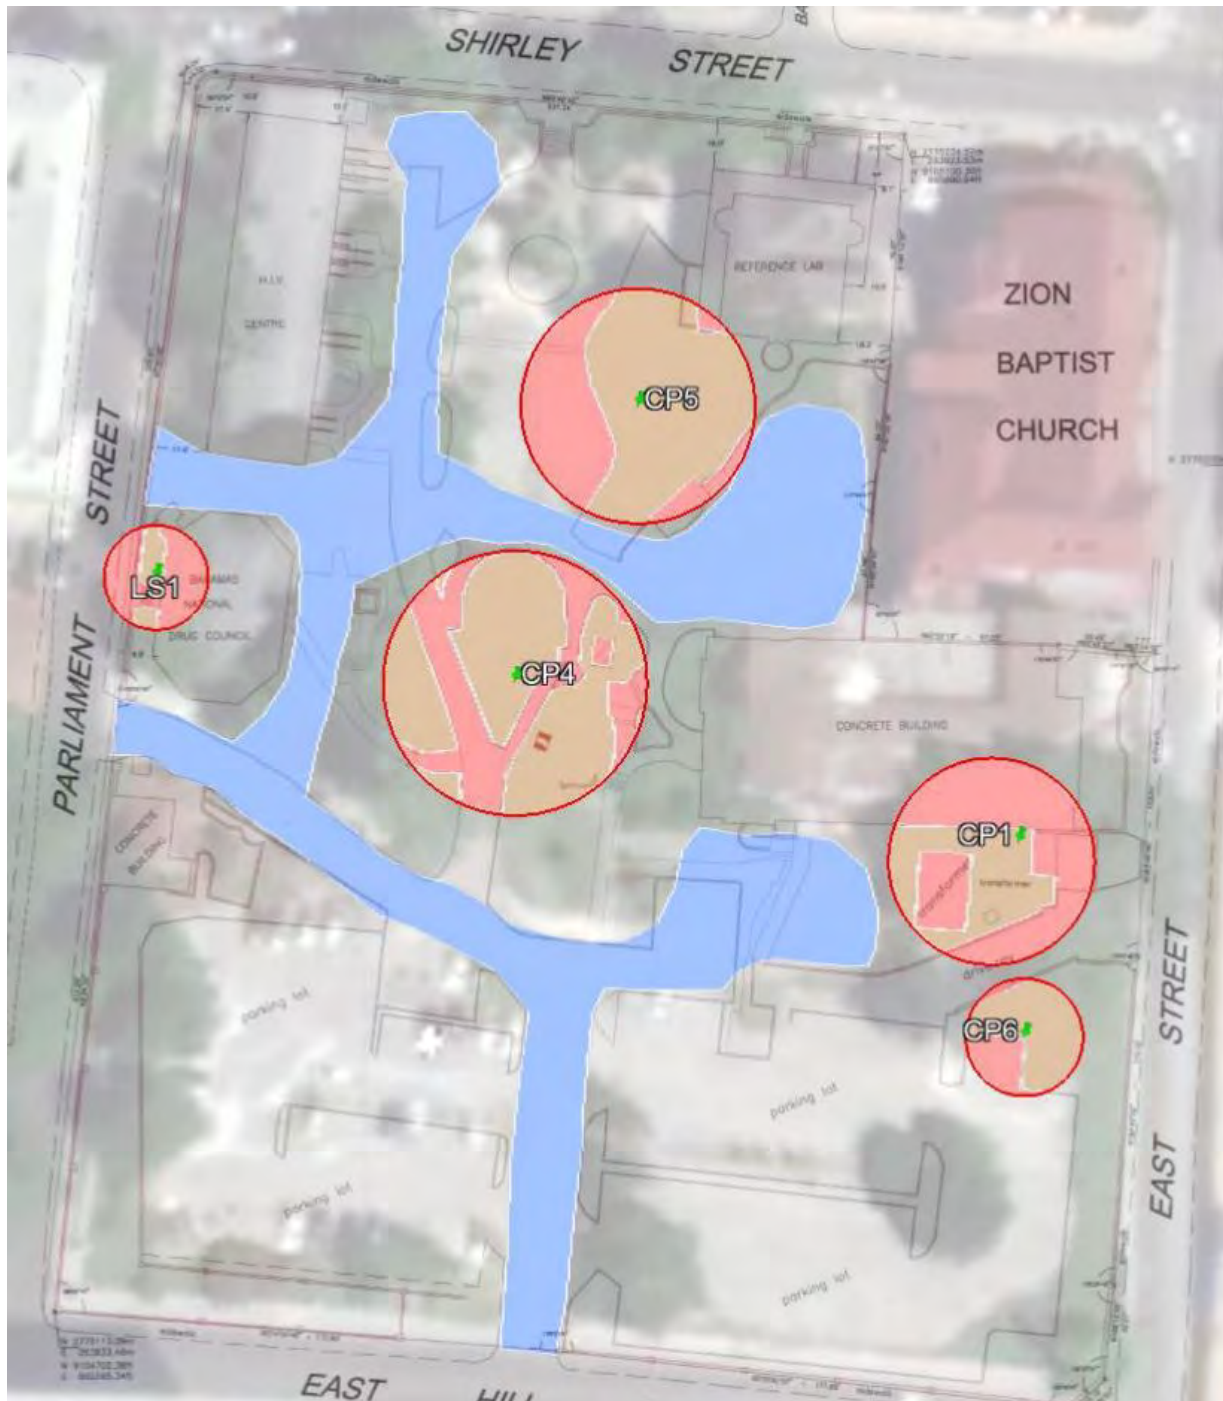
Figure 97. Site route map for vehicular traffic, with CP1,4,5,6;LS1 (nationally protected trees) retained in place, CP2-3 removed.

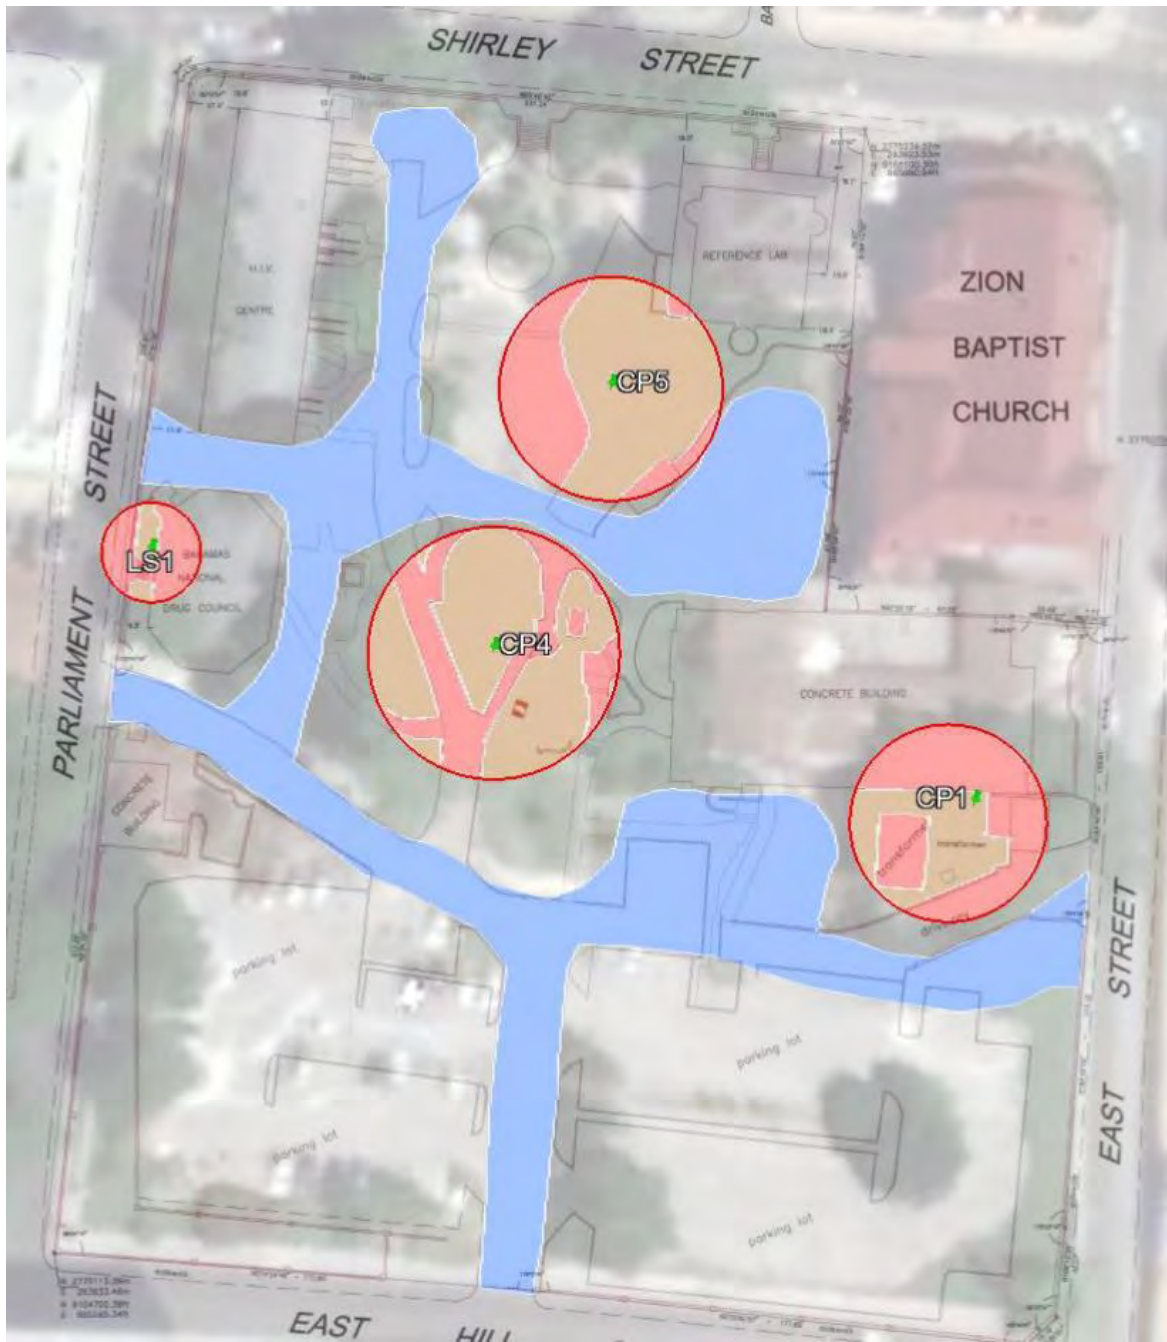
Figure 98. Site route map for vehicular traffic, with CP1,4,5; LS1 (nationally protected trees) retained in place, CP2,3,6 removed.

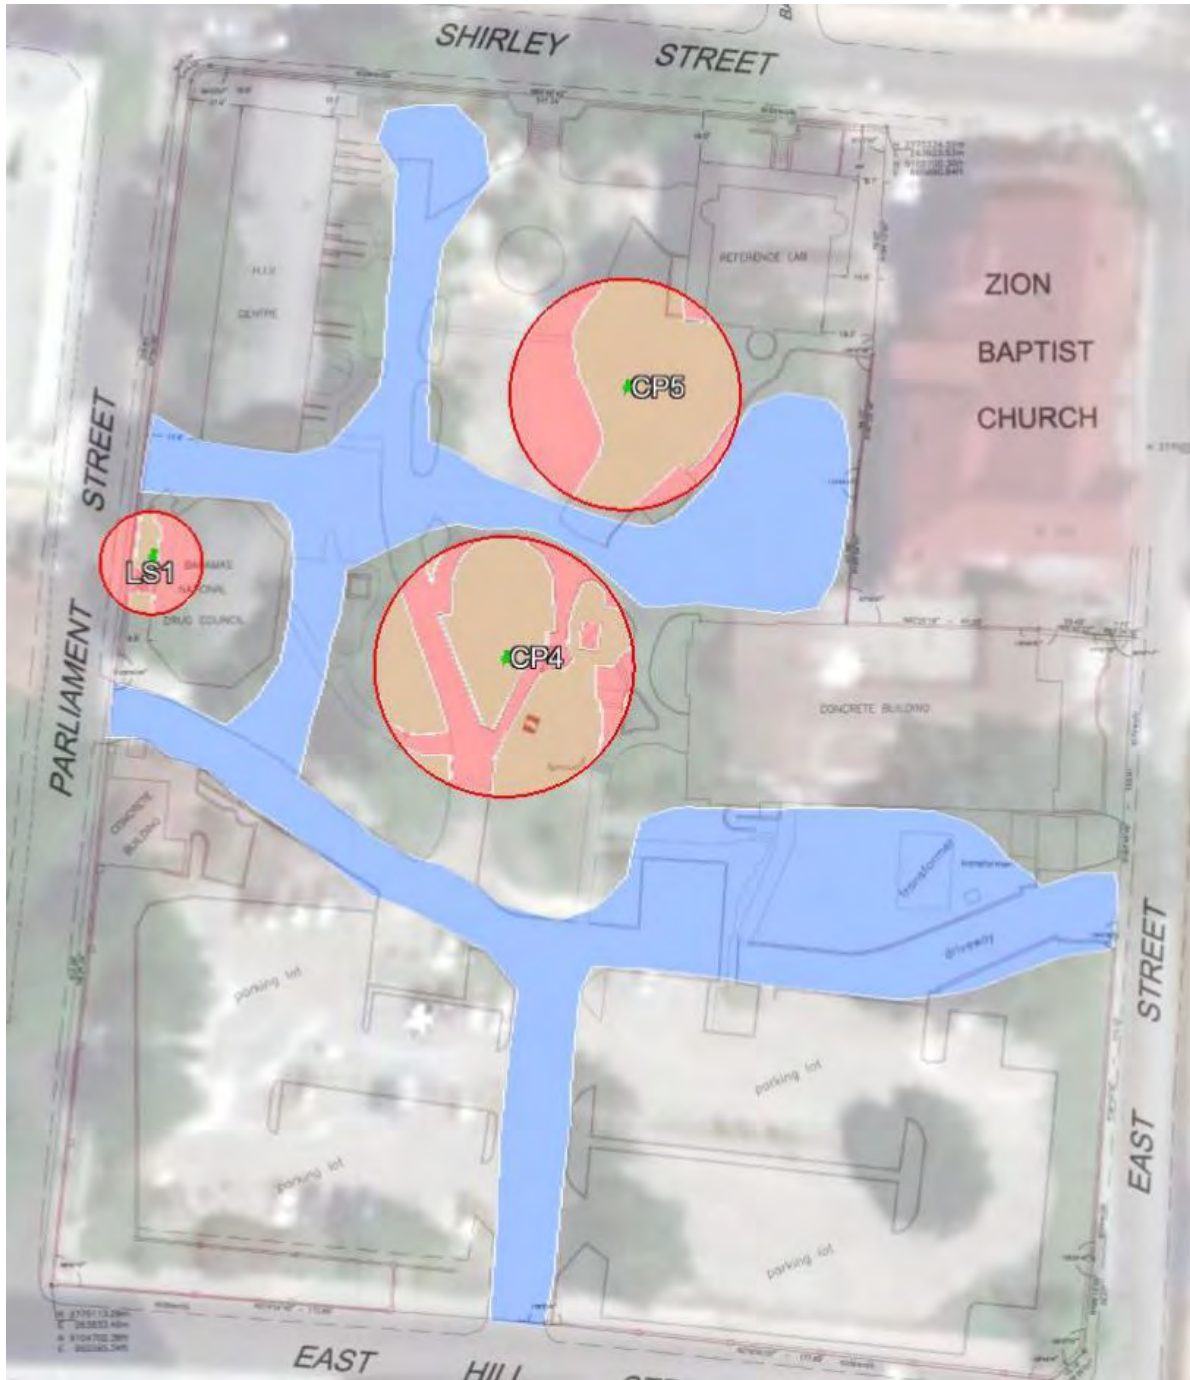
Figure 99. Site route map for vehicular traffic, with CP4,5; LS1 (nationally protected trees) retained in place, CP1,2,3,6 removed.

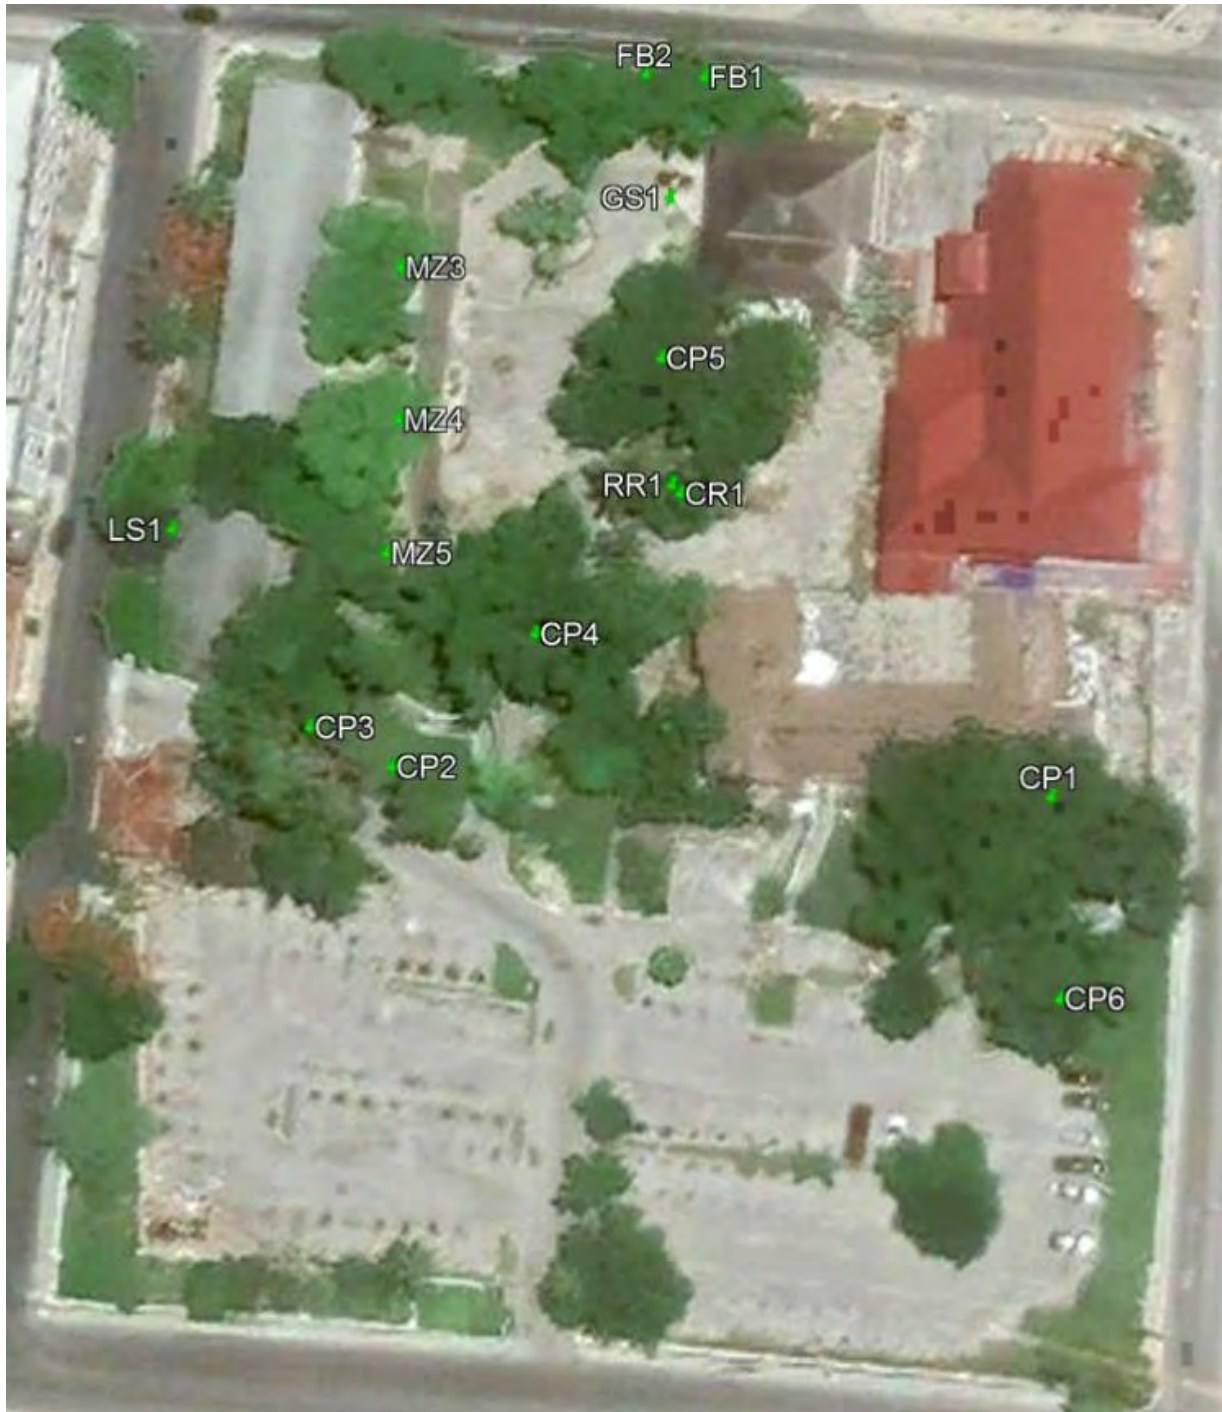
Figure 100. Site map depicting all nationally protected trees, and other specimens recommended for preservation.

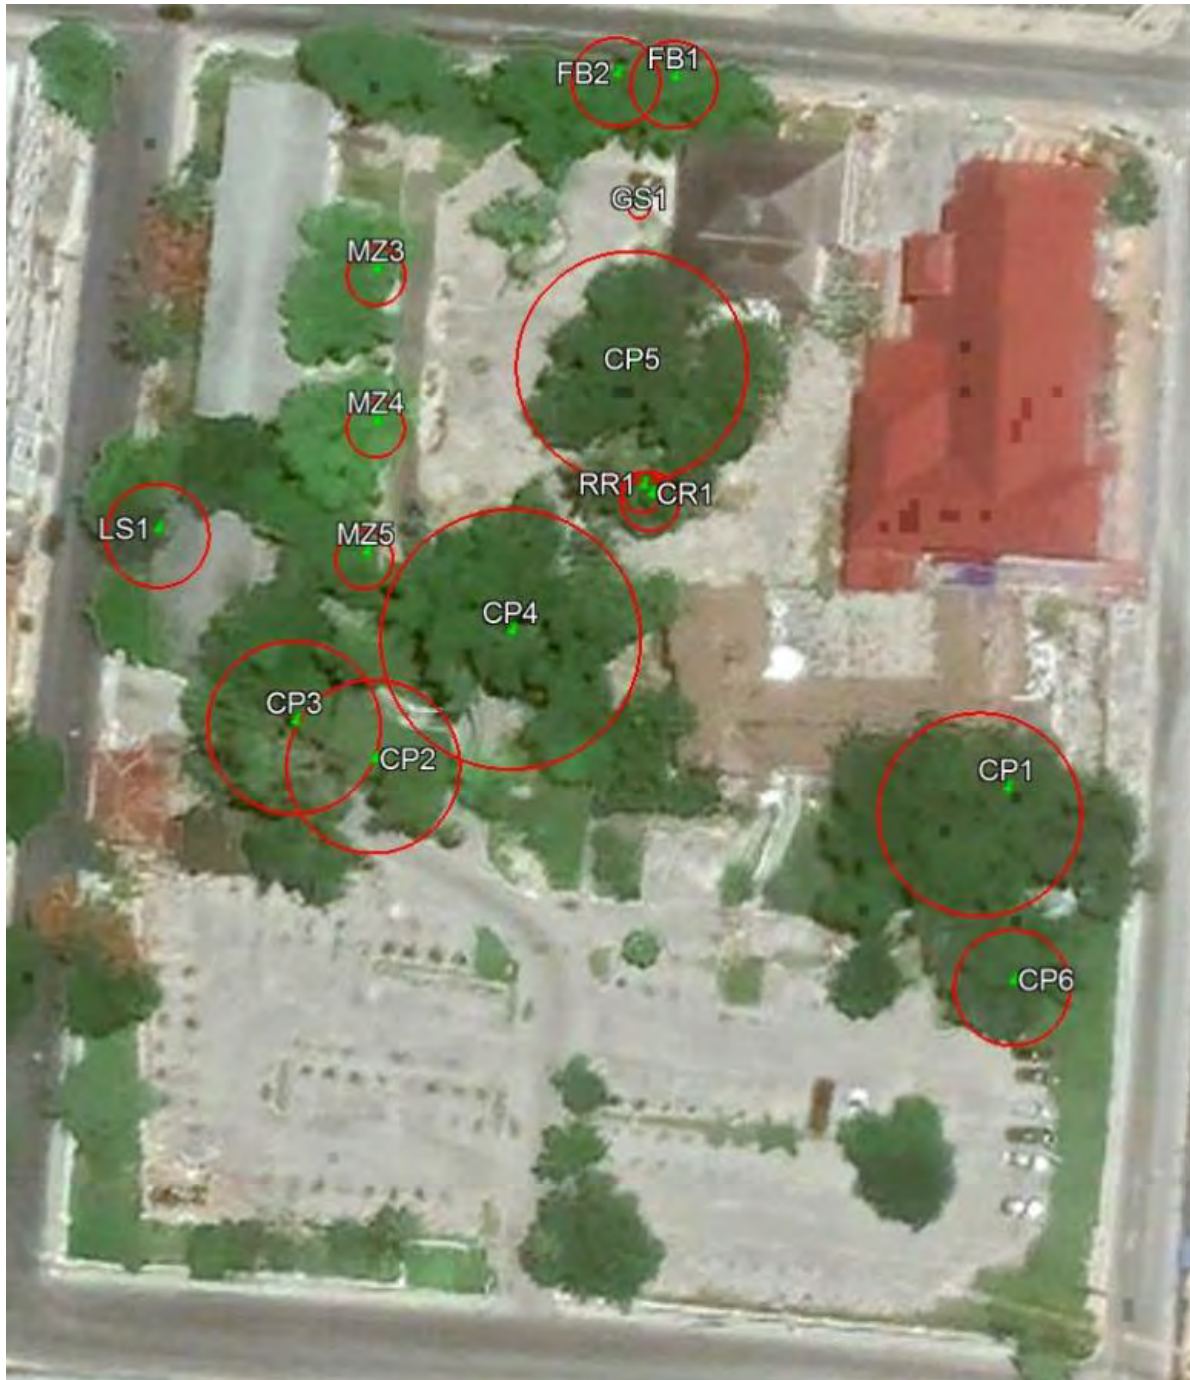
Figure 101. Site map depicting CRZs of all nationally protected trees, and other specimens recommended for preservation

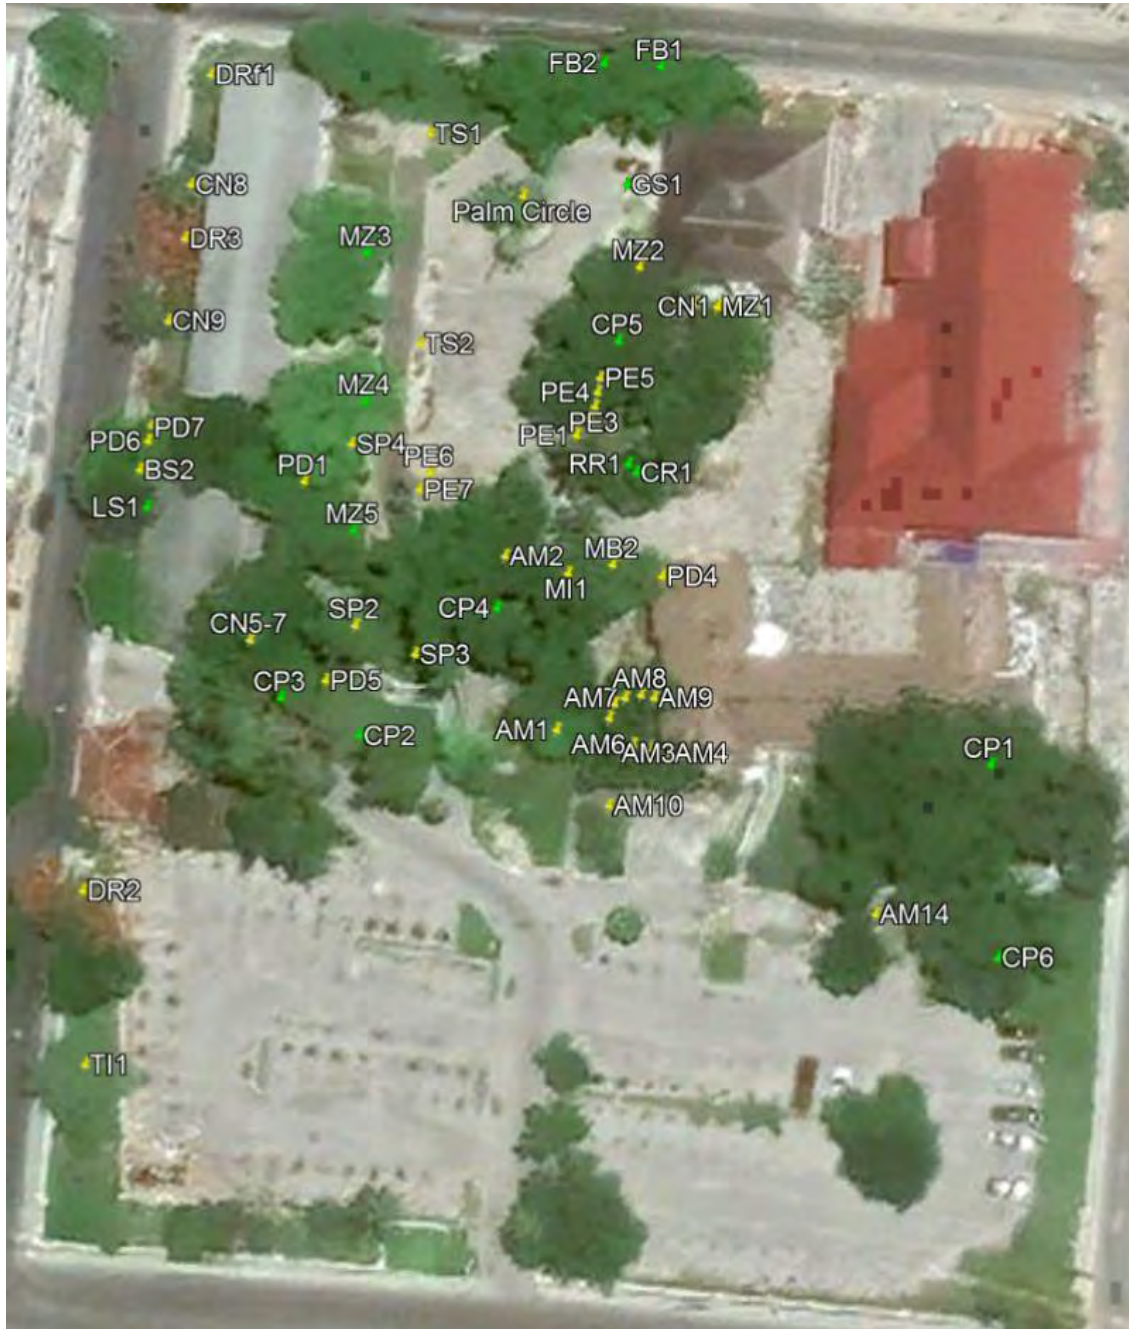
Figure 102. Site map depicting all trees recommended for preservation (Green), and other trees which can be preserved as the final site design allows (yellow).

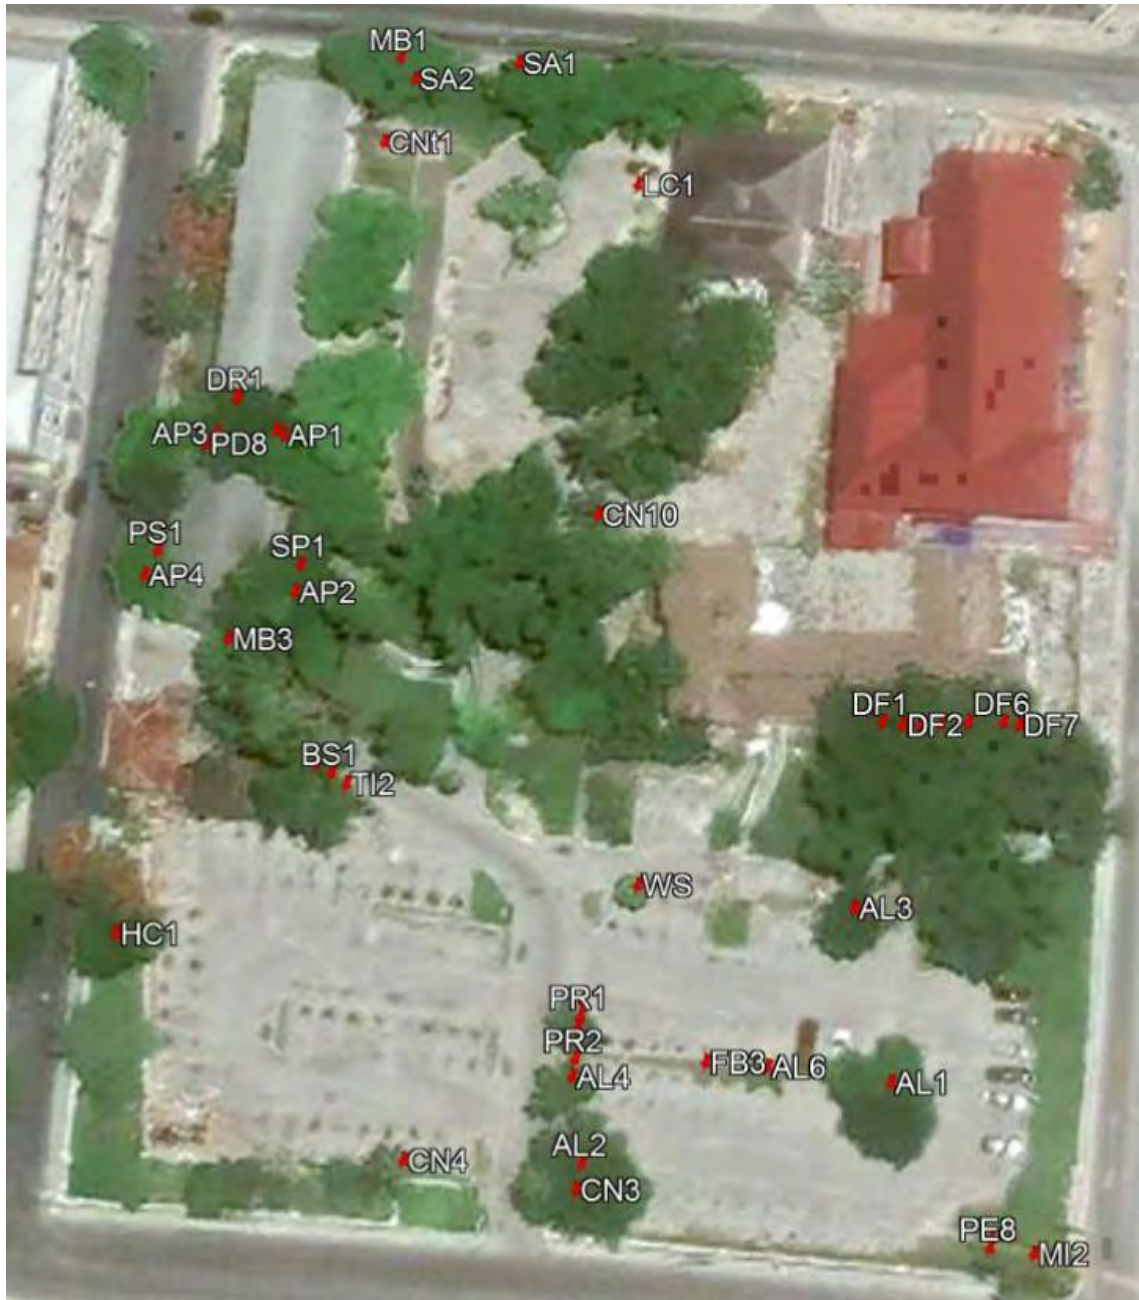
Figure 103. Site map depicting trees recommended for removal.

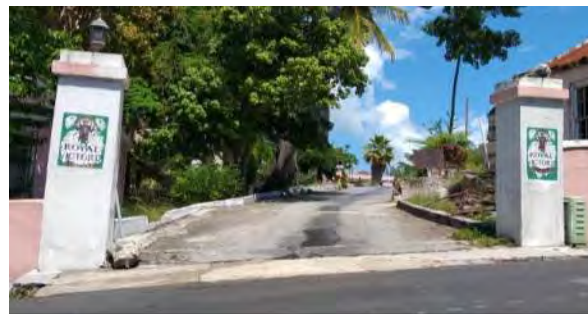
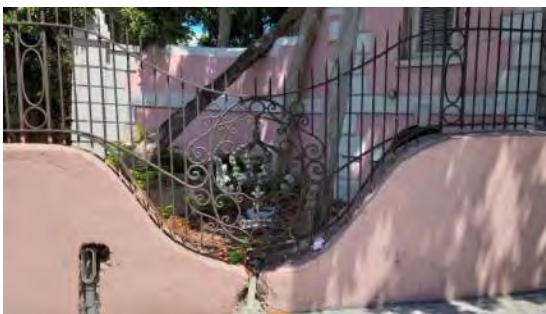
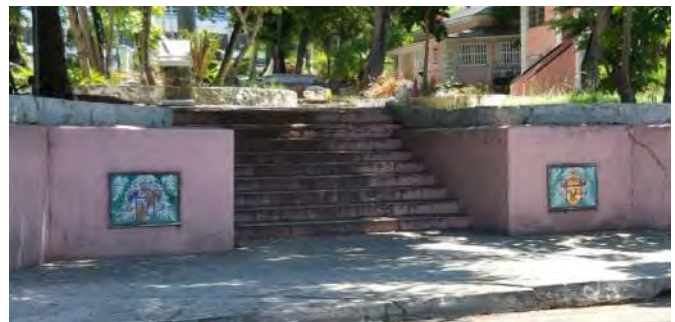
Photos to show some of the historic exterior elements that must also be included in the cataloguing during the deconstruction process.

CATALOGUING: In carrying out the deconstruction a cataloguing system must be put in place for the recording of the components as they are being removed, so that upon reconstruction they can be relocated similarly – to be identified on blueprints.

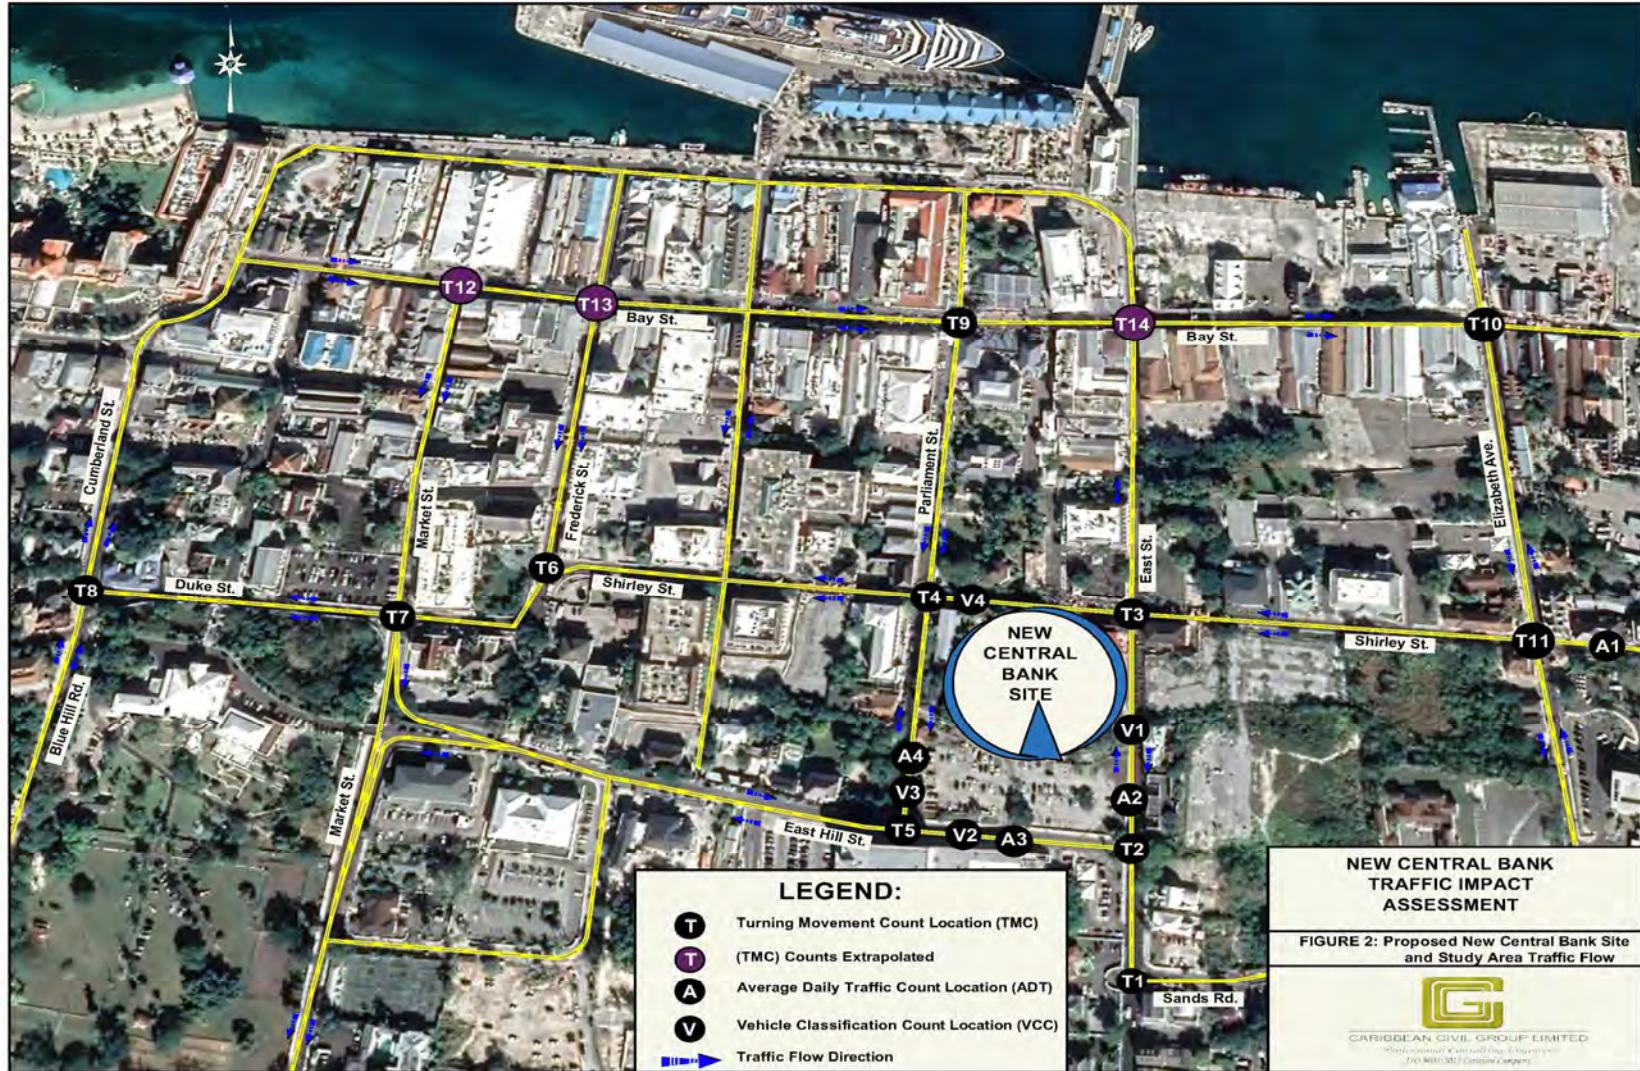
Figure 2 (CBOB Study Area)

The CBOB study area is bounded by Blue Hill Road to the west, Elizabeth Avenue to the East, Bay Street to the north and Sands Road to the south as indicated in **Figure 2** on Page 6.

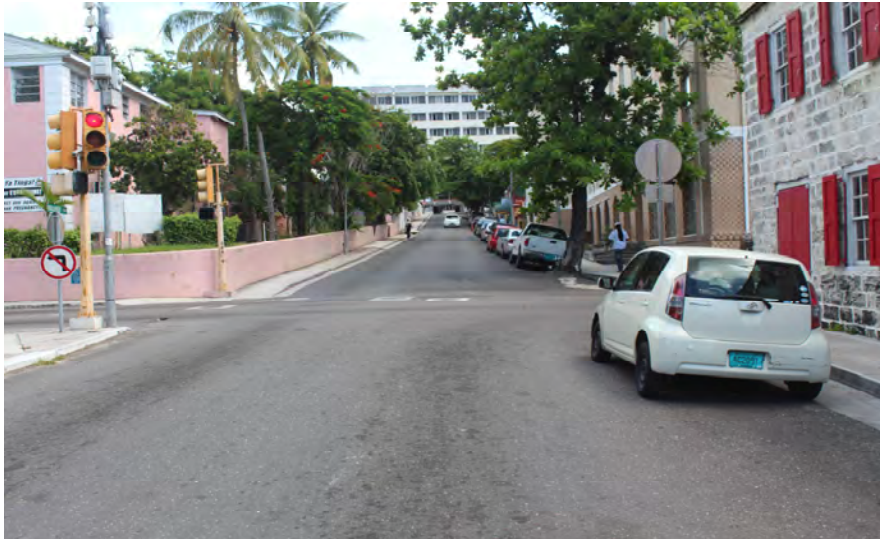
Figure 3 (Parliament Street Looking South)

The new CBOB will be situated on the existing Royal Victoria Gardens site bounded by Parliament Street, East Street, Shirley Street and East Hill Street in the city of Nassau Central Business District (CBD) as shown in **Figure 1** Page 5 and **Figures 3** through **Figures 6** below respectively.

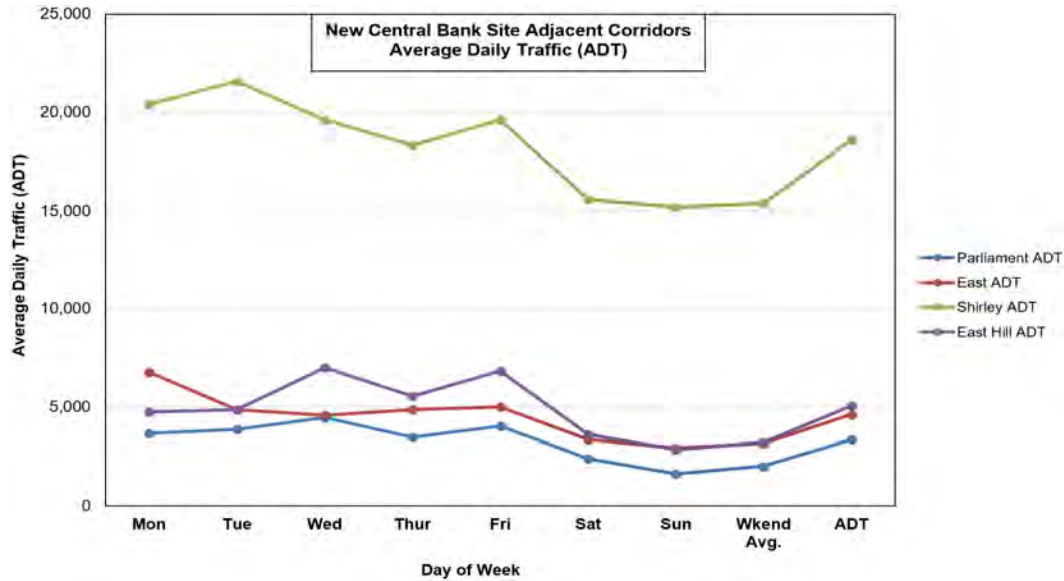
The existing ADT on corridors fronting the proposed CBOB site are outlined below in **Figure 8** through **Figures 13** respectively. The ADT on the minor roadways fronting the property are relatively low volume roadways including East Street between East Hill and Shirley Street.

Figure 8 (Existing ADT On Corridors Adjacent to Site)

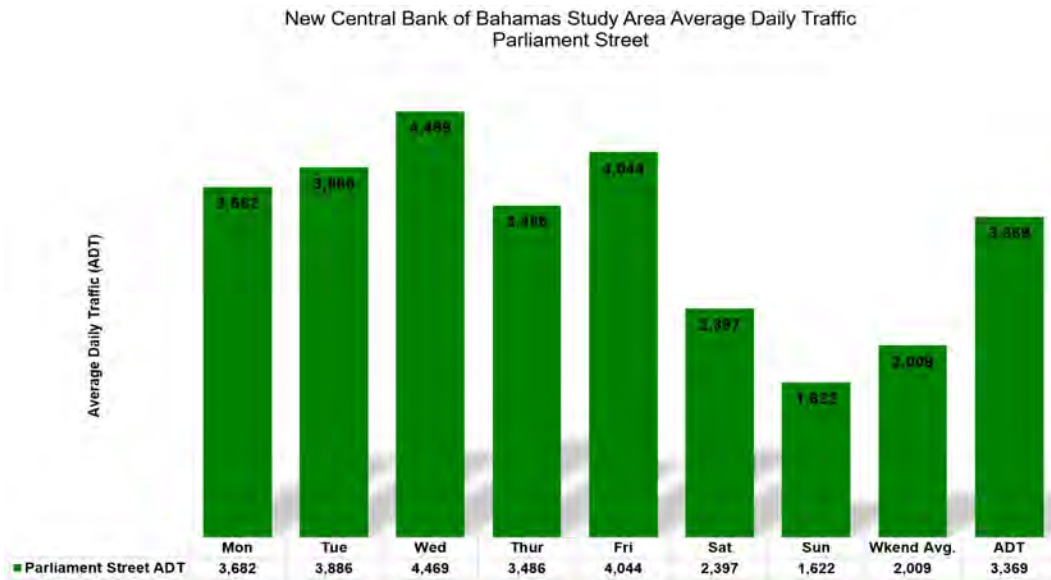
Figure 9 (Existing ADT Parliament Street Fronting Site)

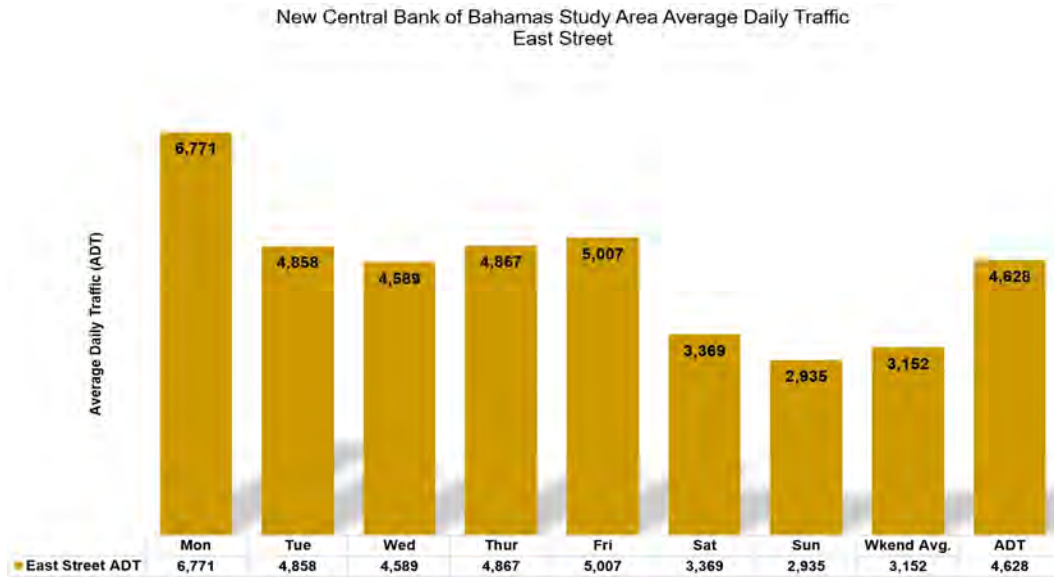
Figure 10 (Existing ADT East Street Fronting Site)

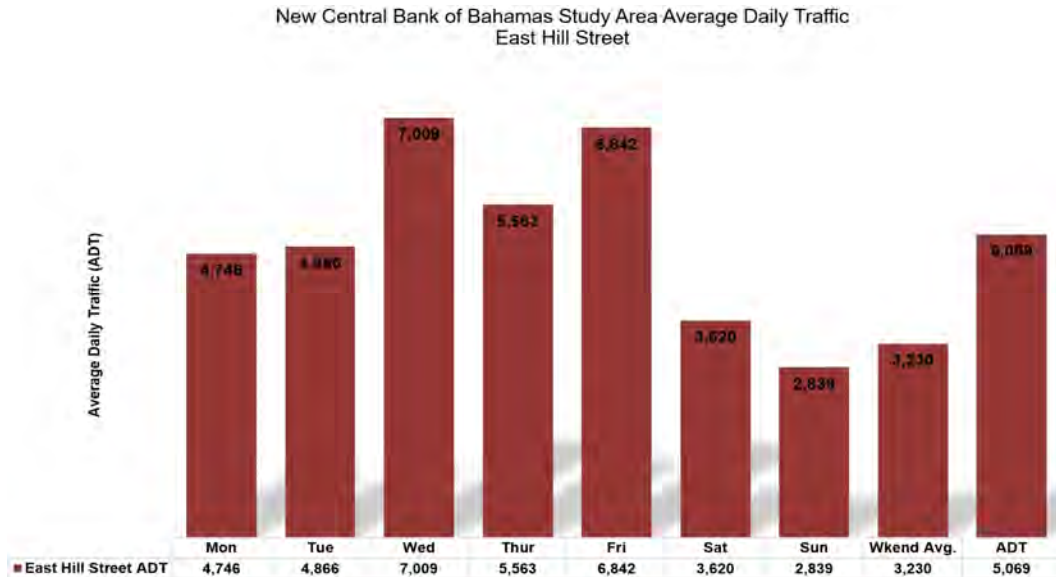
Figure 12 (Existing ADT East Hill Street Fronting Site)

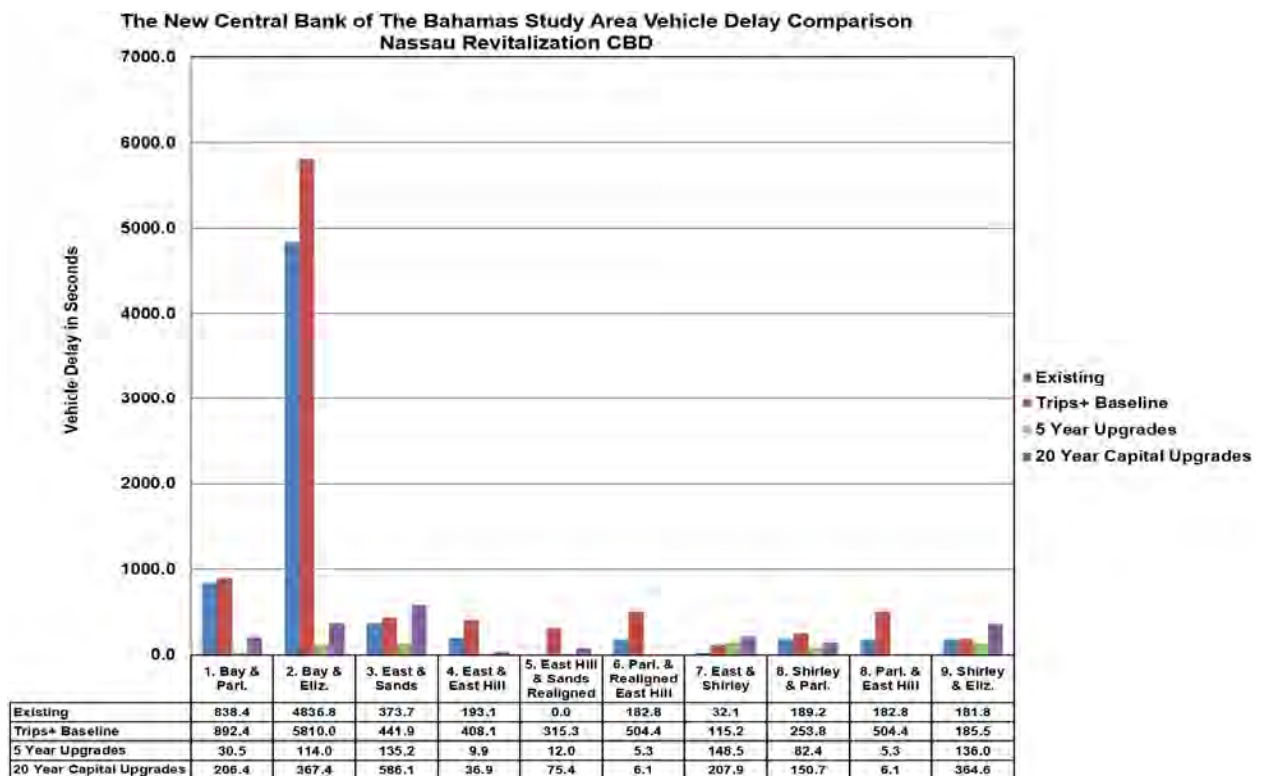
A comparison between the delays for the existing traffic, trips generated plus baseline condition, 5 and 20 year horizon traffic respectively including the capital upgrades recommended are indicated below in **Figure 25**. The capital upgrade over the 20 year horizon indicates a significant improvement in delays compared to a do nothing alternative. The recommended improvements will result in reduced delays and added capacity in the study area at the intersections indicated in Figure 25 below over the 20 year horizon.

Figure 25 (Study Area Delay Comparison)

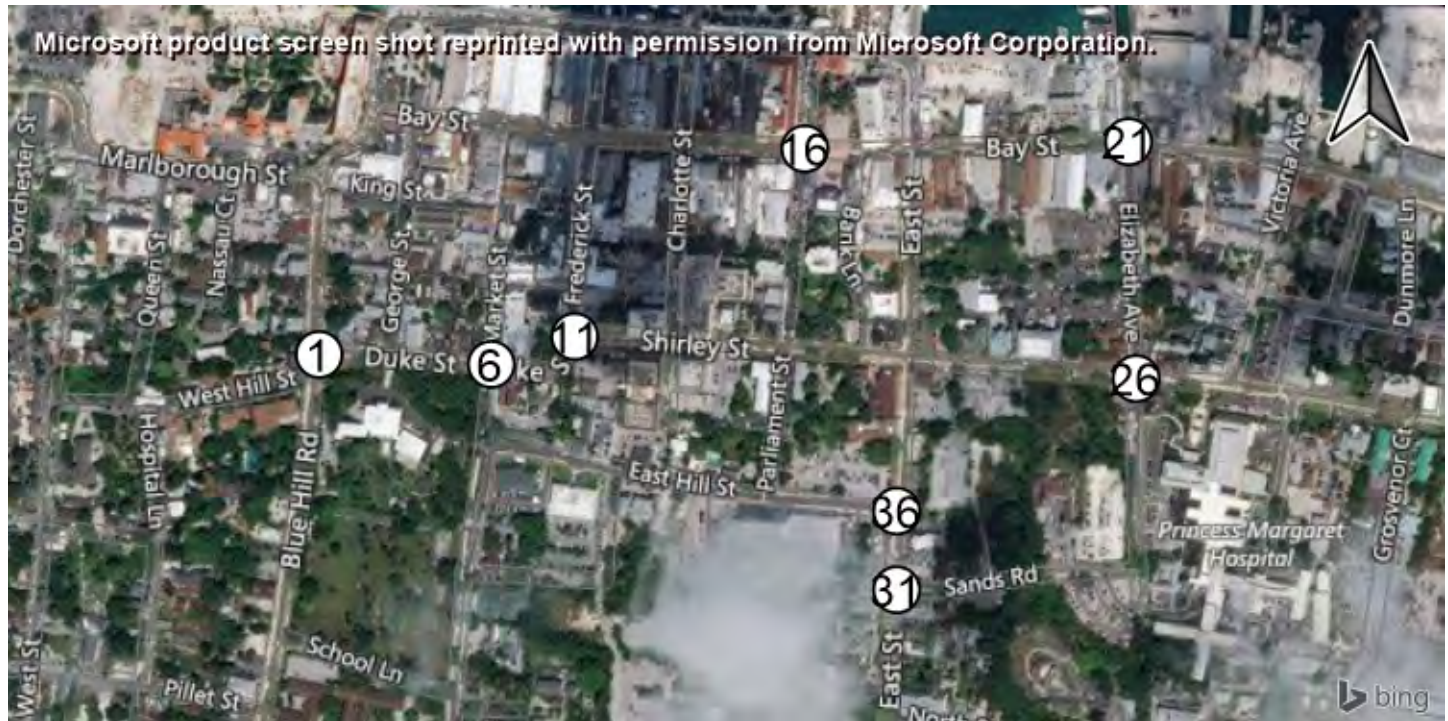
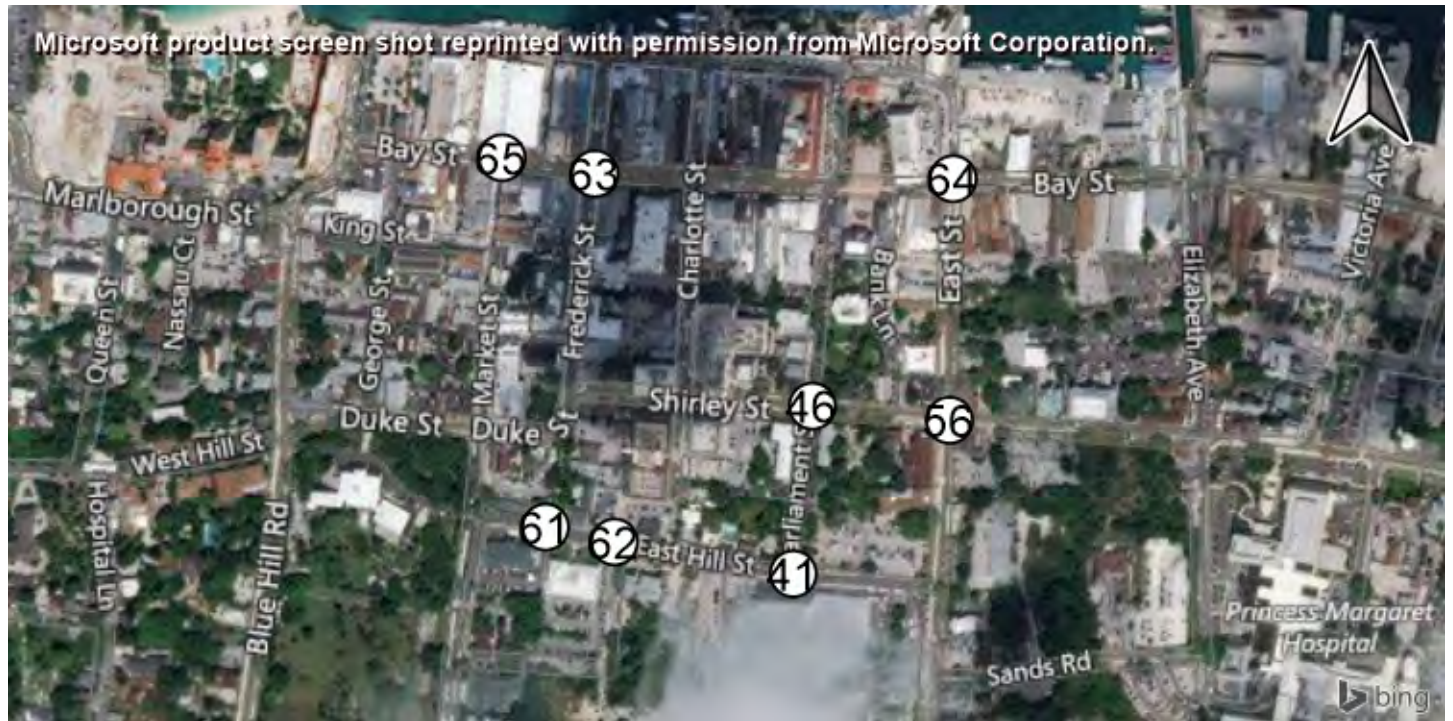
Report Figure 1: Lane Configuration and Traffic Control

Blue Hill Road/Cumberland & Market Street & Duke Street Shirley Street & Frederick Str Bay Street & Parliament Stre

Bay Street & Elizabeth Avenu Shirley Street & Elizabeth Av East Street & Sands Road East Street & East Hill Street

Parliament Street & East Hill Shirley Street & Parliament S East Street & Shirley Street East Hill Street Slip Roads

East Hill Street & RBC Parkin Bay Street & Frederick Street Bay Street & East Street Bay Street & Market Street
