Environmental Impact Assessment:
The Central Bank of The Bahamas
New Premises - REVISION 1

06 September 2021

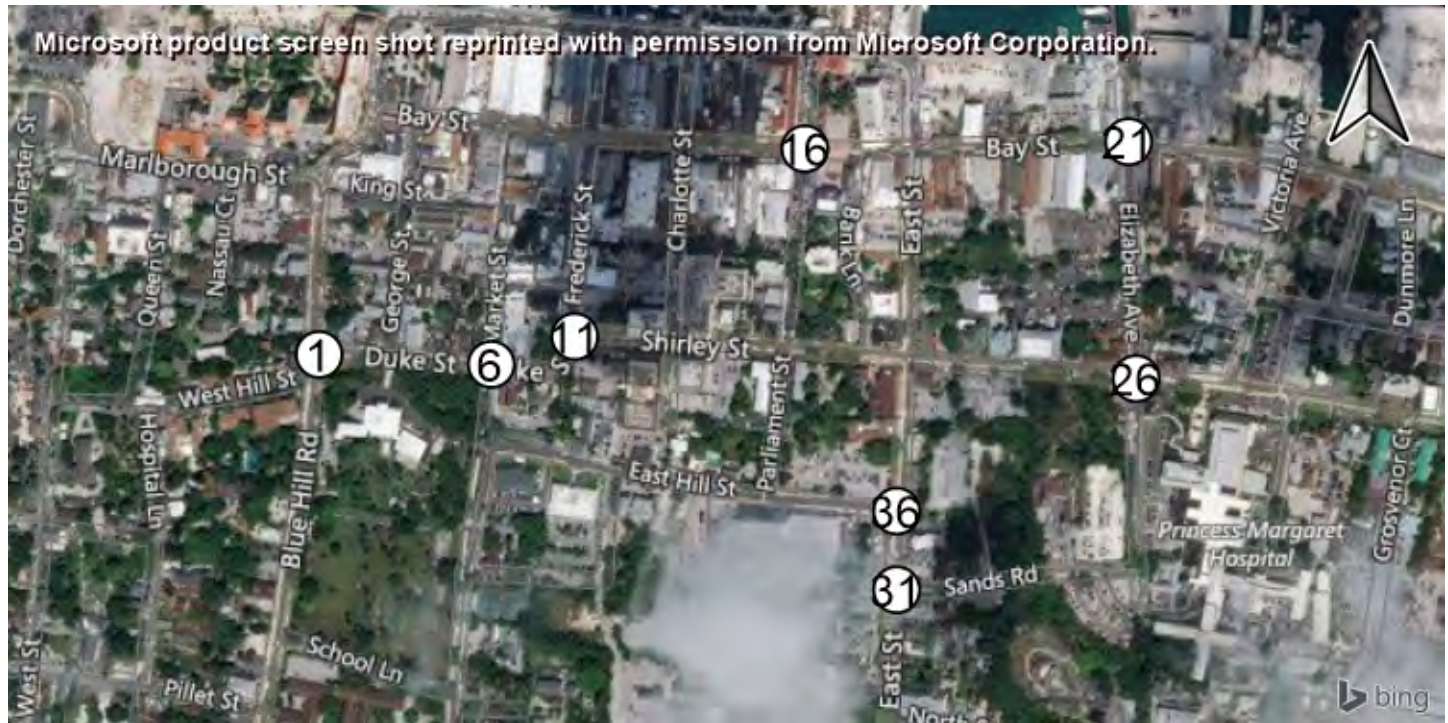
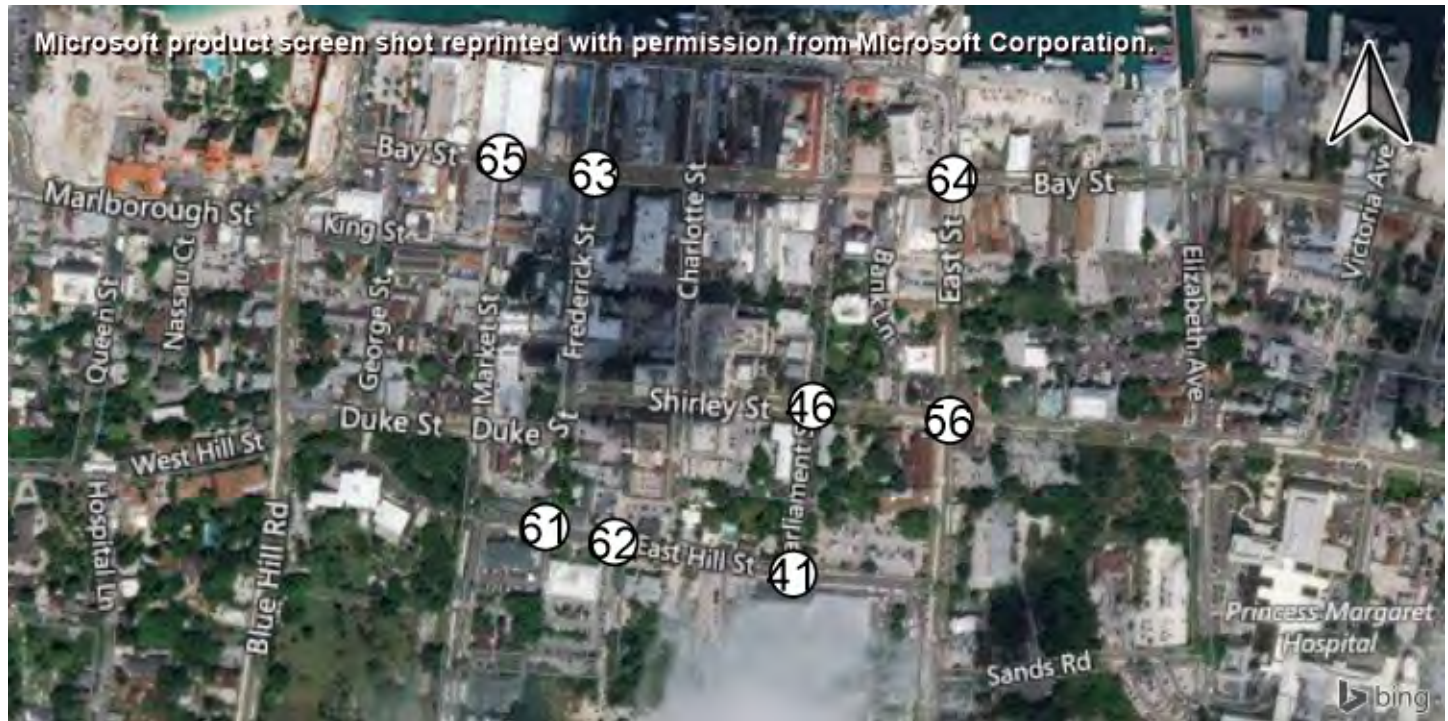
Report Figure 2a: Traffic Volume - Base Volume

Blue Hill Road/Cumberland & Market Street & Duke Street Shirley Street & Frederick Str Bay Street & Parliament Stre

Bay Street & Elizabeth Avenu Shirley Street & Elizabeth Av East Street & Sands Road East Street & East Hill Street

Parliament Street & East Hill Shirley Street & Parliament S East Street & Shirley Street East Hill Street Slip Roads

East Hill Street & RBC Parkin Bay Street & Frederick Street Bay Street & East Street Bay Street & Market Street

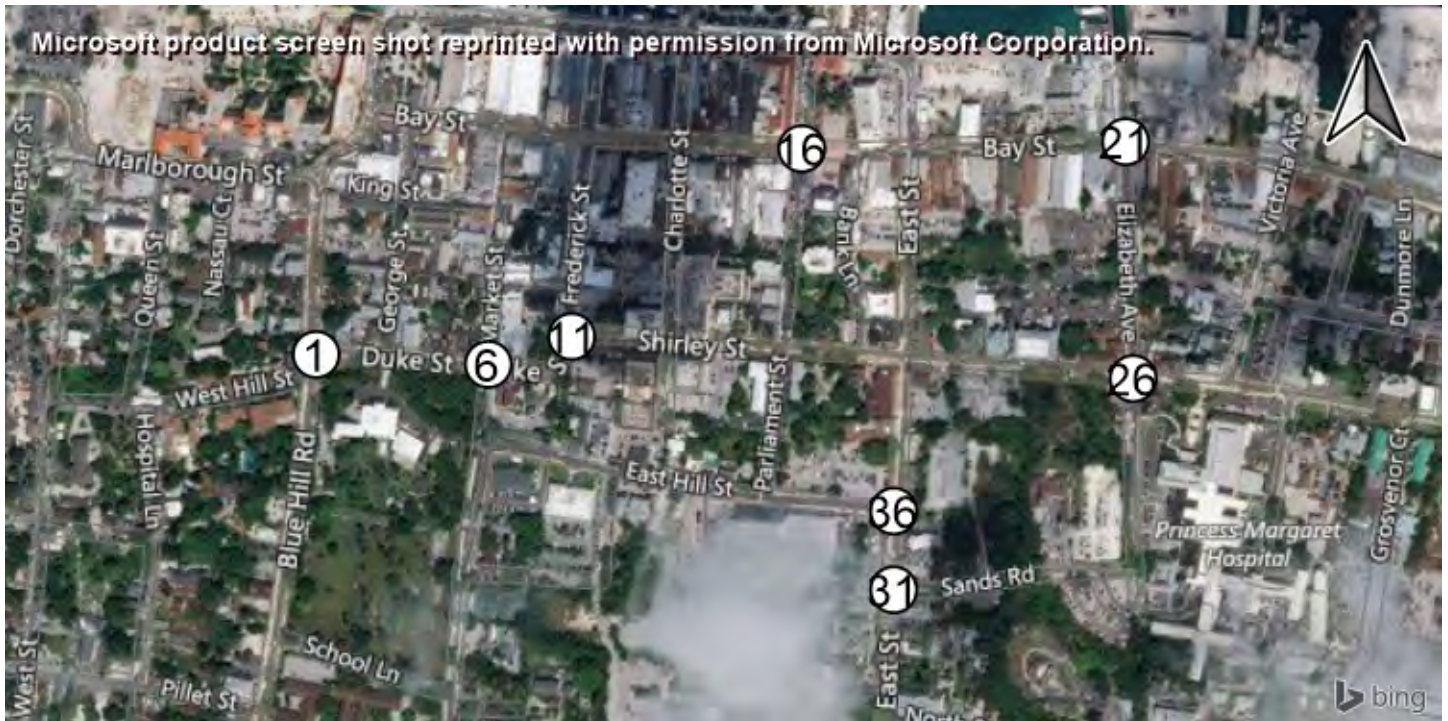
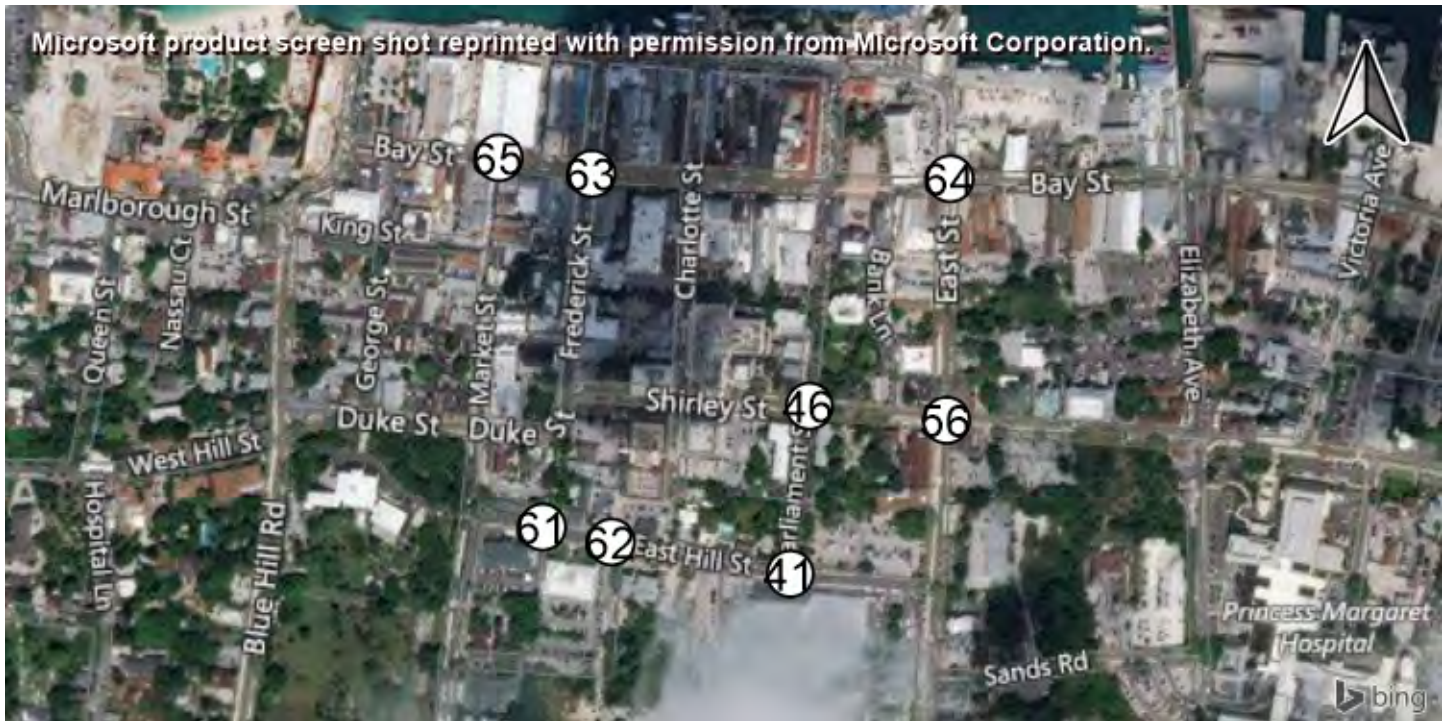
Report Figure 1: Lane Configuration and Traffic Control

Blue Hill Road/Cumberland & Market Street & Duke Street Shirley Street & Frederick Str Bay Street & Parliament Stre

Bay Street & Elizabeth Avenu Shirley Street & Elizabeth Av East Street & Sands Road East Street & East Hill Street

Parliament Street & East Hill Shirley Street & Parliament S East Street & Shirley Street East Hill Street Slip Roads

East Hill Street & RBC Parkin Bay Street & Frederick Street Bay Street & East Street Bay Street & Market Street

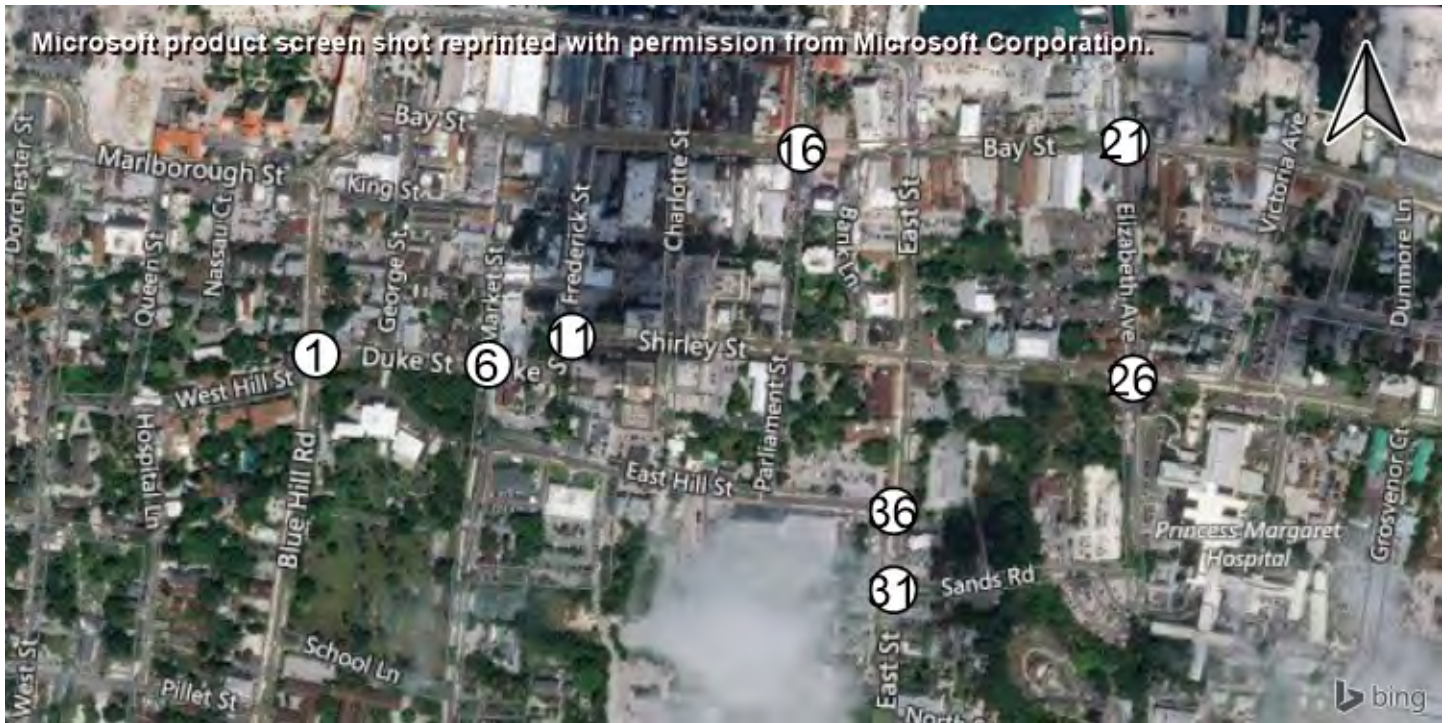
Report Figure 2f: Traffic Volume - Future Total Volume

Blue Hill Road/Cumberland & Market Street & Duke Street Shirley Street & Frederick Str Bay Street & Parliament Stre

Bay Street & Elizabeth Avenu Shirley Street & Elizabeth Av East Street & Sands Road East Street & East Hill Street

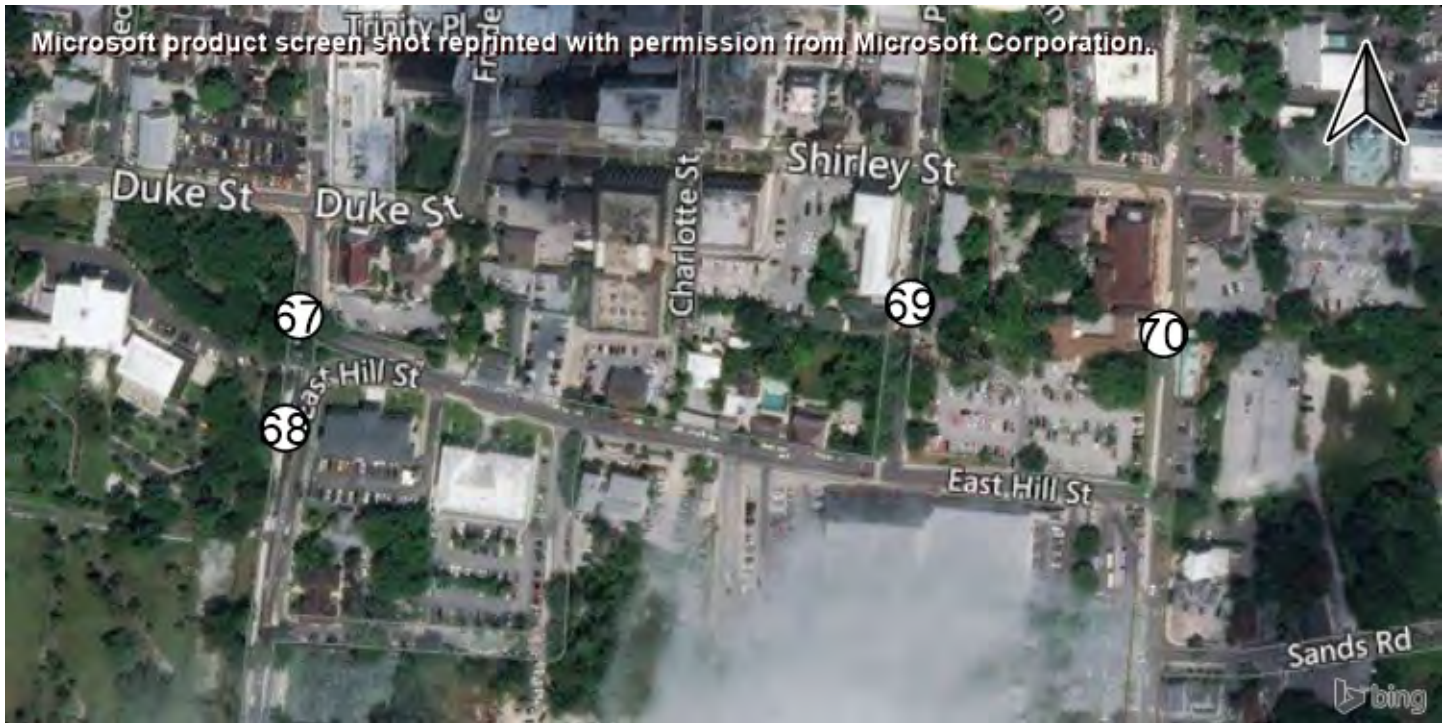
Report Figure 2f: Traffic Volume - Future Total Volume

Market St. & Peck Slope Slip Market St. & East Hill Slip La CBOB Parliament Entrance CBOB East Street Access

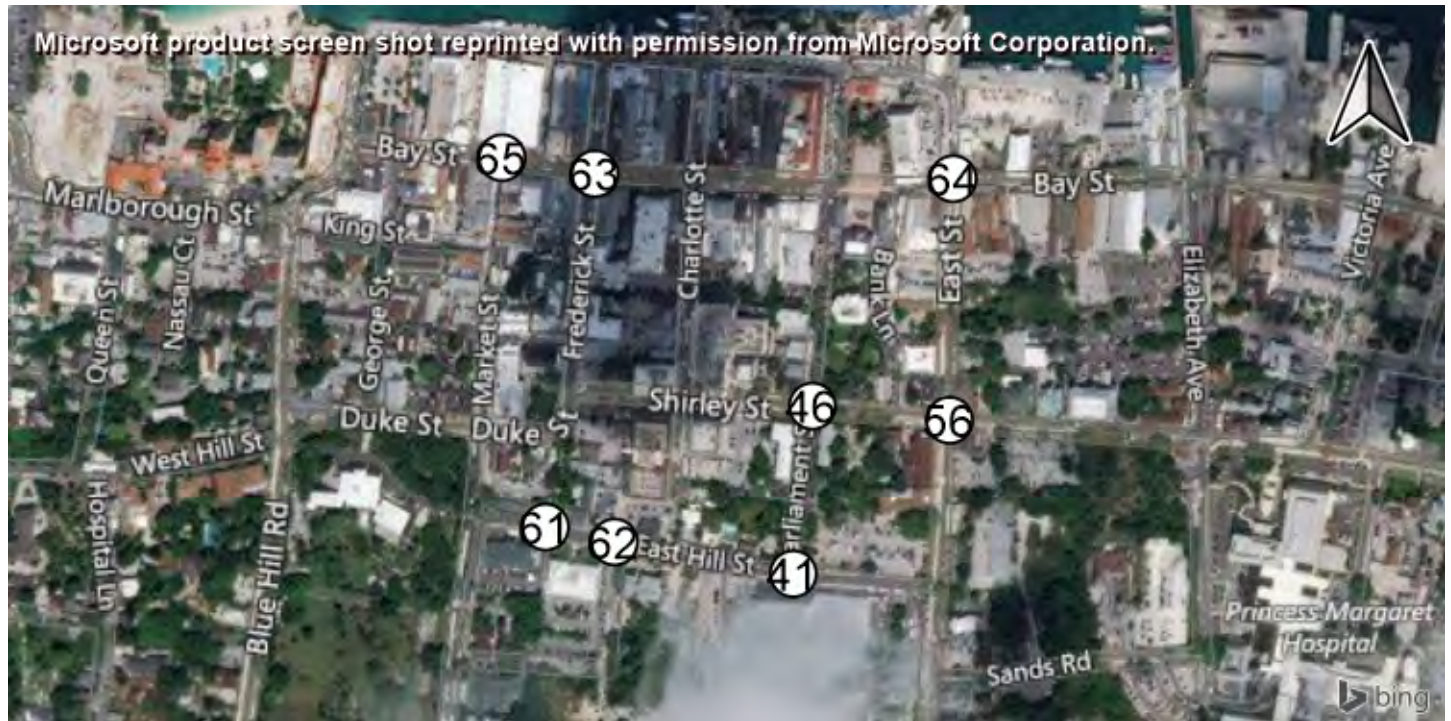
Report Figure 2f: Traffic Volume - Future Total Volume

Parliament Street & East Hill Shirley Street & Parliament S East Street & Shirley Street East Hill Street Slip Roads

East Hill Street & RBC Parkin Bay Street & Frederick Street Bay Street & East Street Bay Street & Market Street

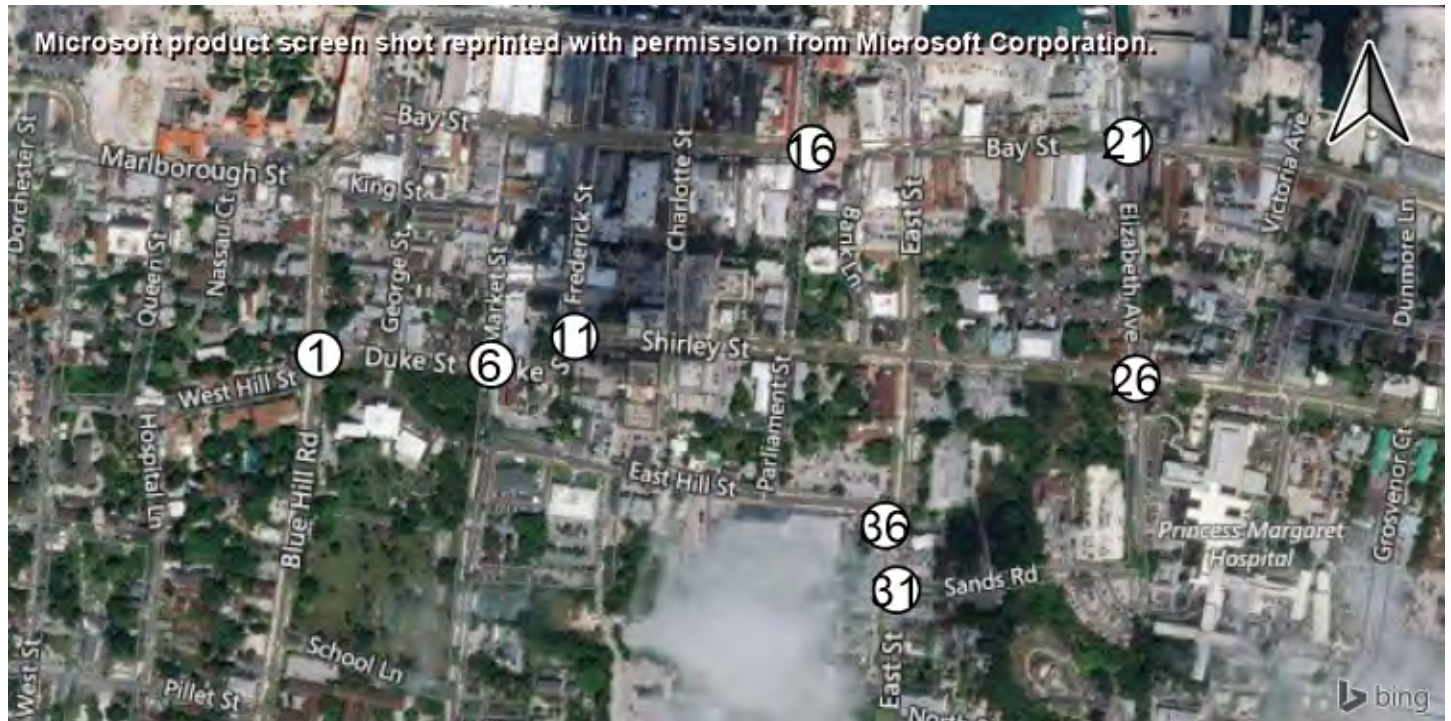
Report Figure 1: Lane Configuration and Traffic Control

Blue Hill Road/Cumberland & Market Street & Duke Street Shirley Street & Frederick Str Bay Street & Parliament Stre

Bay Street & Elizabeth Avenu Shirley Street & Elizabeth Av East Street & Sands Road East Street & East Hill Street

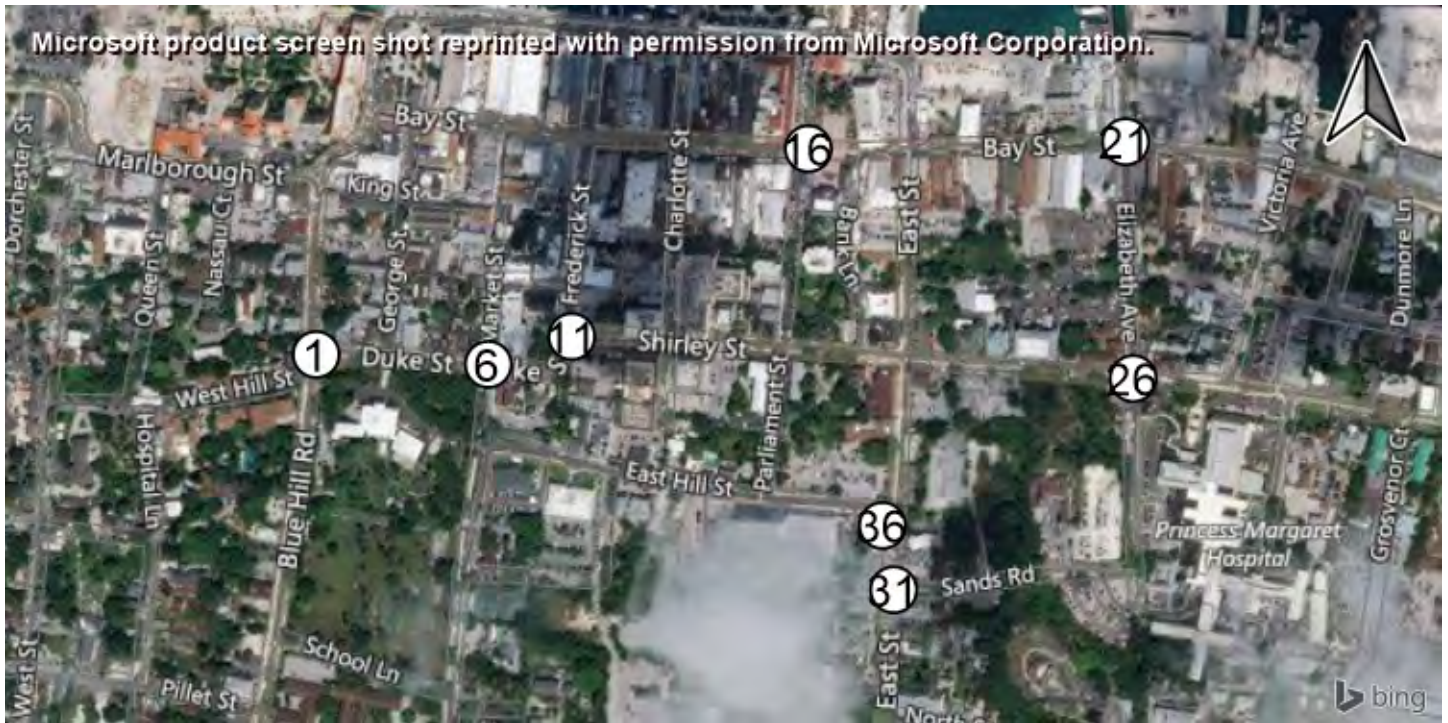
Report Figure 2f: Traffic Volume - Future Total Volume

Blue Hill Road/Cumberland & Market Street & Duke Street Shirley Street & Frederick Str Bay Street & Parliament Stre

Bay Street & Elizabeth Avenu Shirley Street & Elizabeth Av East Street & Sands Road East Street & East Hill Street

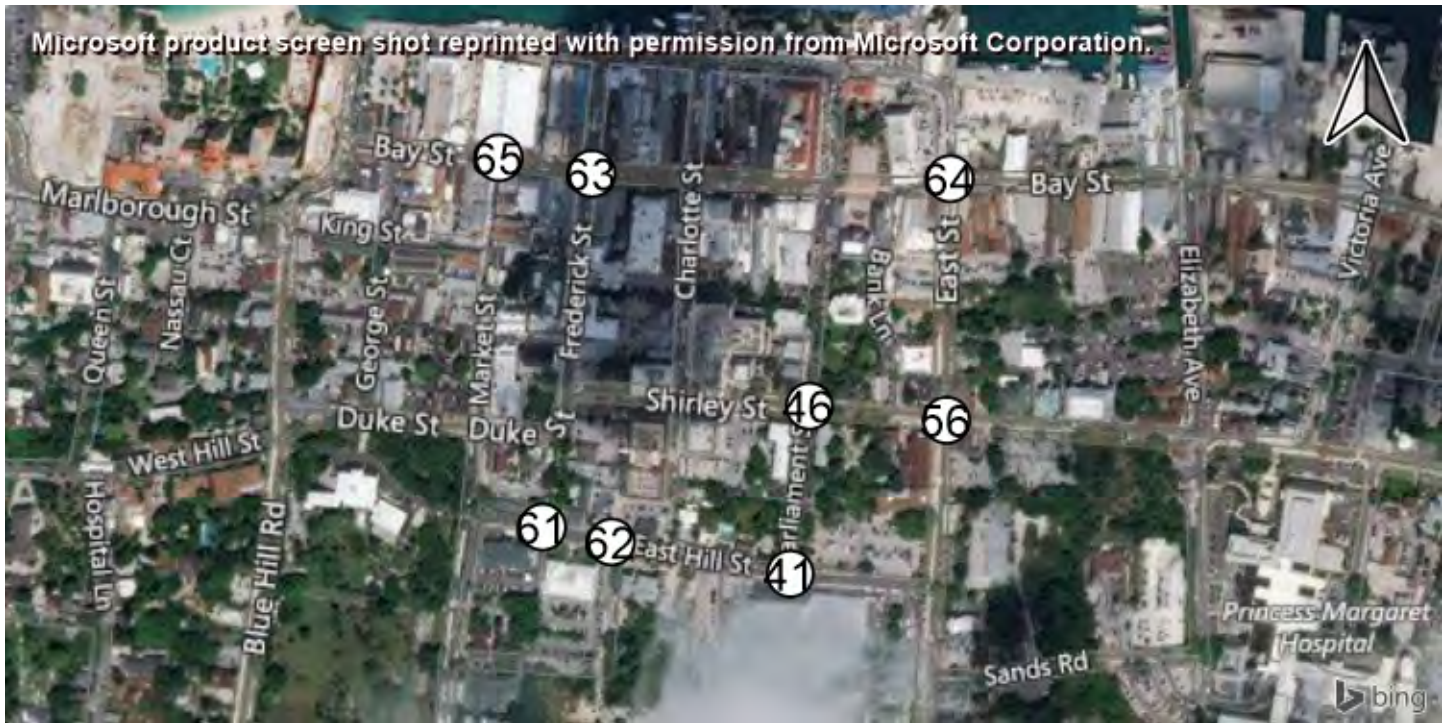
Report Figure 2f: Traffic Volume - Future Total Volume

Parliament Street & East Hill Shirley Street & Parliament S East Street & Shirley Street East Hill Street Slip Roads

East Hill Street & RBC Parkin Bay Street & Frederick Street Bay Street & East Street Bay Street & Market Street

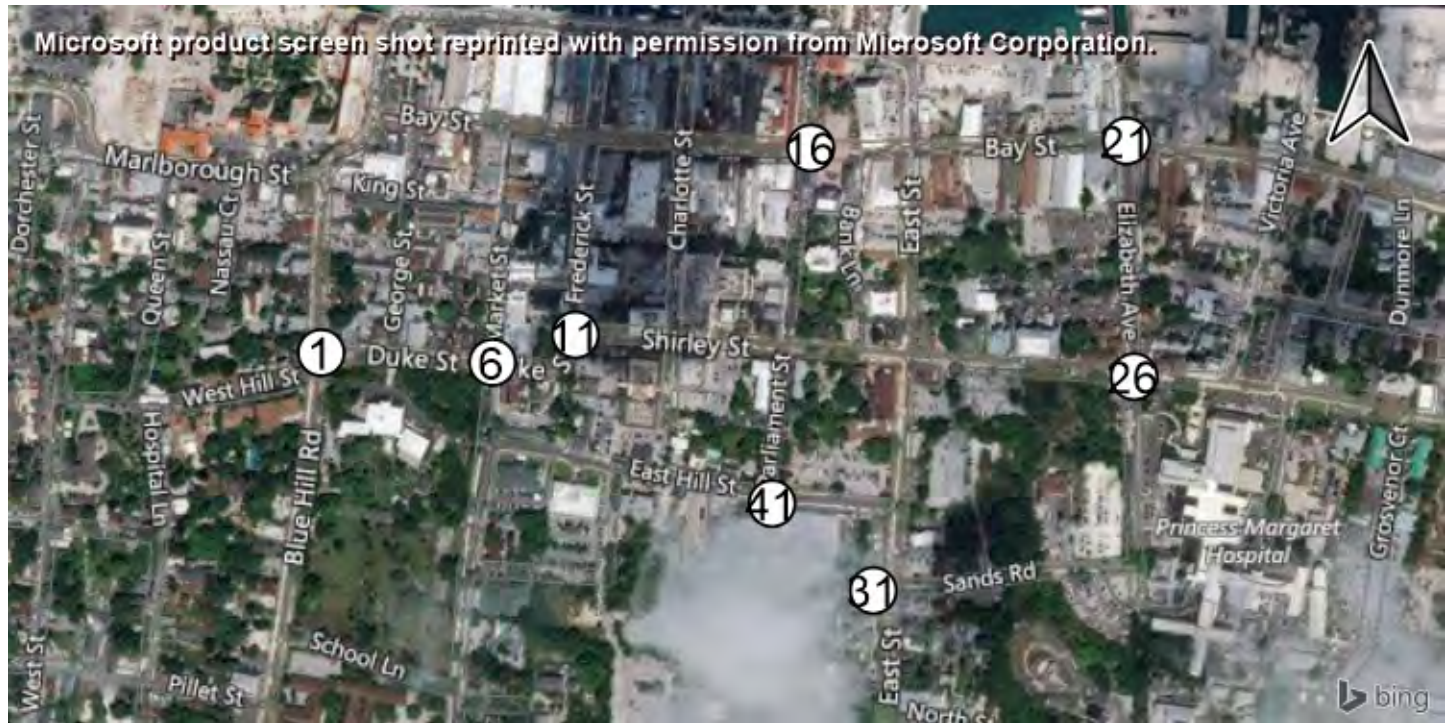
Report Figure 1: Lane Configuration and Traffic Control

Blue Hill Road/Cumberland & Market Street & Duke Street Shirley Street & Frederick Str Bay Street & Parliament Stre

Bay Street & Elizabeth Avenu Shirley Street & Elizabeth Av East Street & Sands Road (R Parliament Street & East Hill

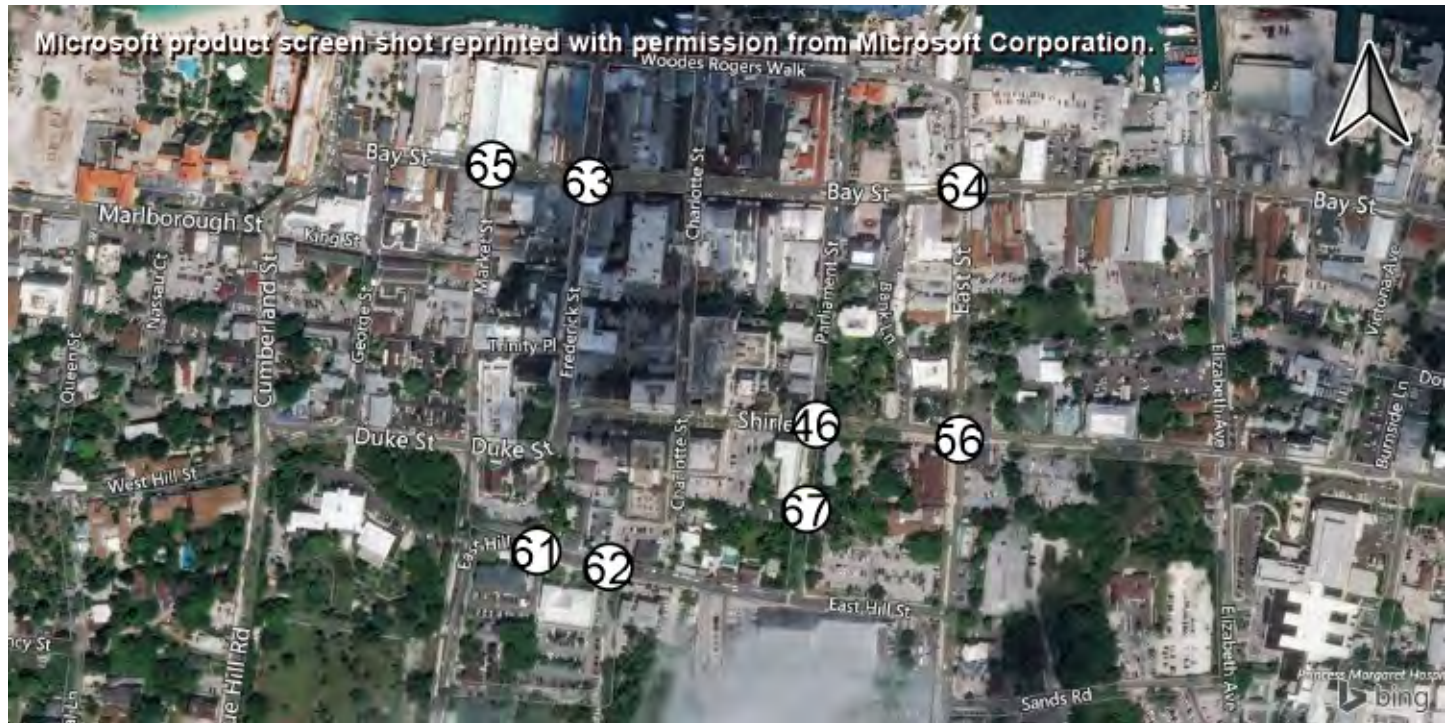
Report Figure 1: Lane Configuration and Traffic Control

Shirley Street & Parliament S East Street & Shirley Street East Hill Street Slip Roads East Hill Street & RBC Parkin

Bay Street & Frederick Street Bay Street & East Street Bay Street & Market Street CBOB Parliament Access

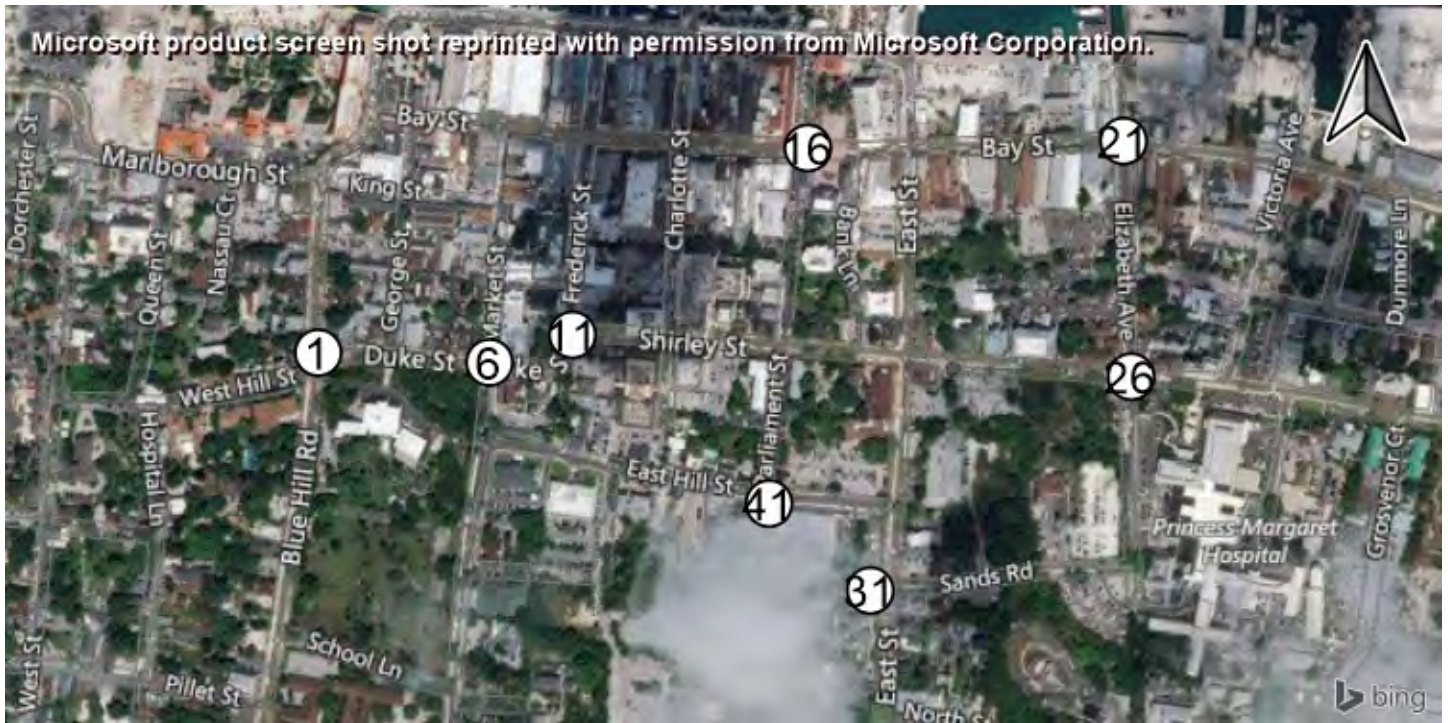
Report Figure 2f: Traffic Volume - Future Total Volume

Blue Hill Road/Cumberland & Market Street & Duke Street Shirley Street & Frederick Str Bay Street & Parliament Stre

Bay Street & Elizabeth Avenu Shirley Street & Elizabeth Av East Street & Sands Road (R Parliament Street & East Hill

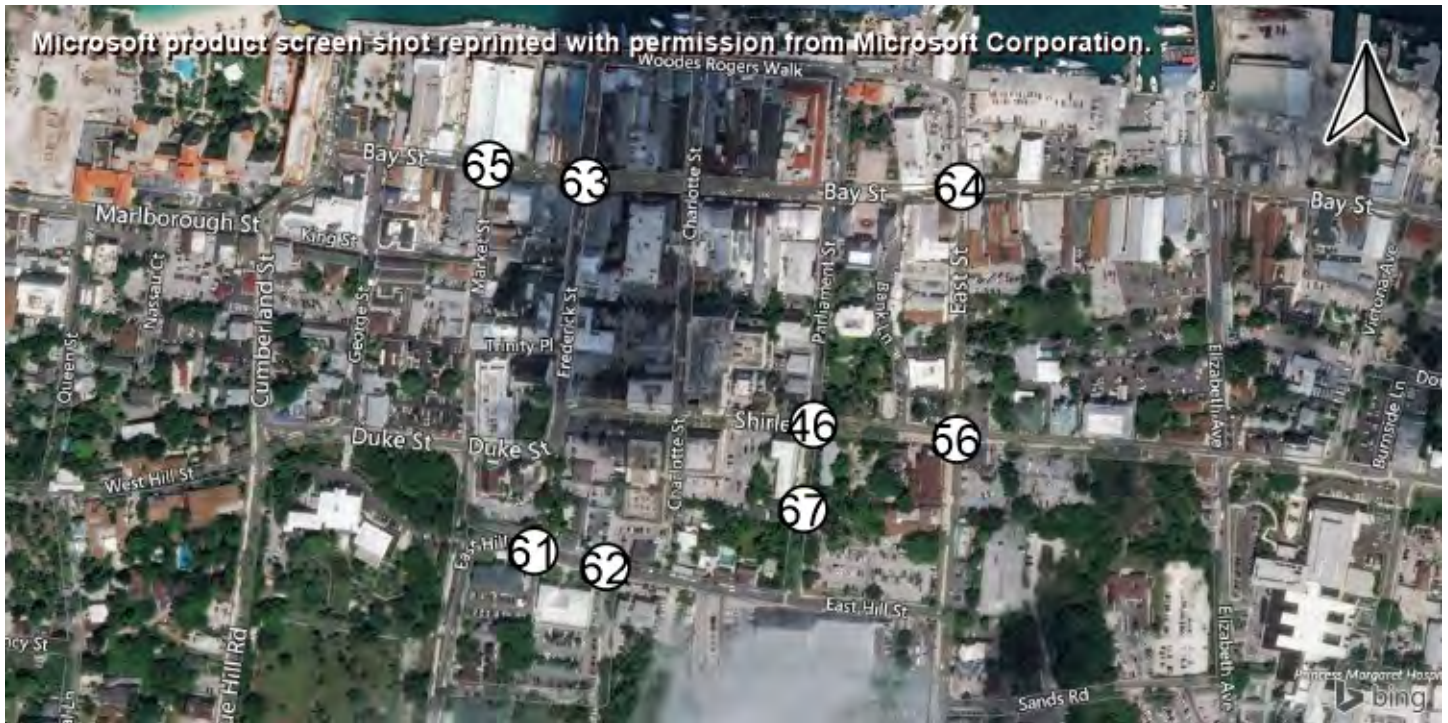
Report Figure 2f: Traffic Volume - Future Total Volume

Shirley Street & Parliament S East Street & Shirley Street East Hill Street Slip Roads East Hill Street & RBC Parkin

Bay Street & Frederick Street Bay Street & East Street Bay Street & Market Street CBOB Parliament Access
